This supplementary Site Inspection Record for existing structures presents the Consultant's findings in respect of all the bridges and tunnels on the project railway line from Kumanovo to Bulgarian border. This report is additional to the requirements of the Terms of Reference and Task 4 Development of Preferred Alternative for the Feasibility Study. This report summarises the research into the condition of the bridges and tunnels and is used for consequential costs for their construction or finalisation.

BRIDGE INSPECTION RECORD (NO ACCESS TO THE OBJECT)							
Bridge		Bridge No.	length	width	chainage	Bridge type	Date of Inspection
Section	MAVROVO 37+624 - 44+390	7	2X25 (50m)	6.5m	km 40+014.00	RC Viaduct	29.03.2011

BRIDGE INSPECTION RECORD							
Bridge		Bridge No.	length	width	chainage	Bridge type	Date of Inspection
Section	GRANIT 44+390 - 55+500	12	13X36 (468m)	6.5m	km 46+068.00	RC Viaduct	29.03.2011

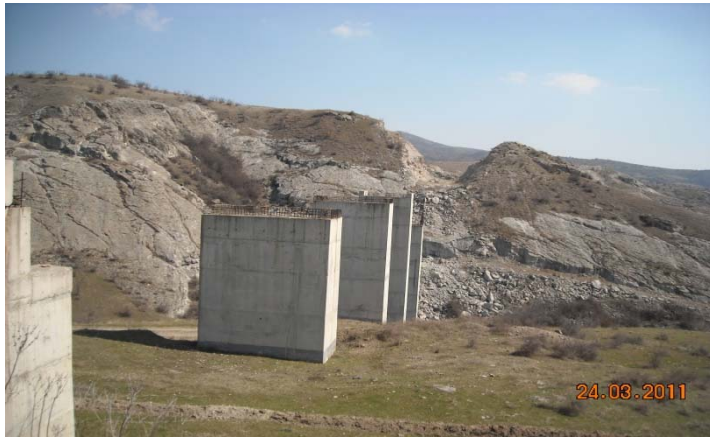
No	ELEMENT	CONDITION CLASS	DEFECTS DESCRIPTION	MEASURES
1	Abutments	1	(constructed 1st oval abutment, 8th not constructed) no visual defects	
2	Piers	2	(3 piers completely constructed, on 5th pier miss kampada, 6th and 7th not constructed) corrode reinfor.	to clean reinforcement if the intersection is not damage
3	Deck		not constructed	
4	Culvert		not constructed	
5	Bearing areas		not constructed	
6	Main Girders/Beams		not constructed	
7	Cross Girders		not constructed	
7	Expansion joints		not constructed	
8	Drainage system		not constructed	
9	Level of Completion (%)		1. SUBSTRUCTURE 65% SUPERSTRUCTURE 0%	2.
10	Designing		Main Project

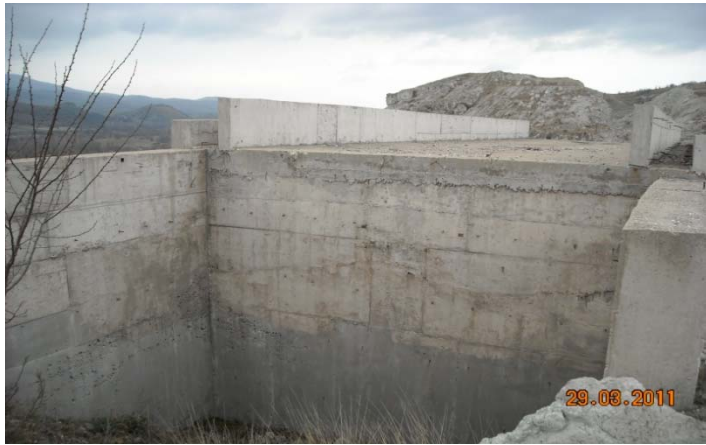
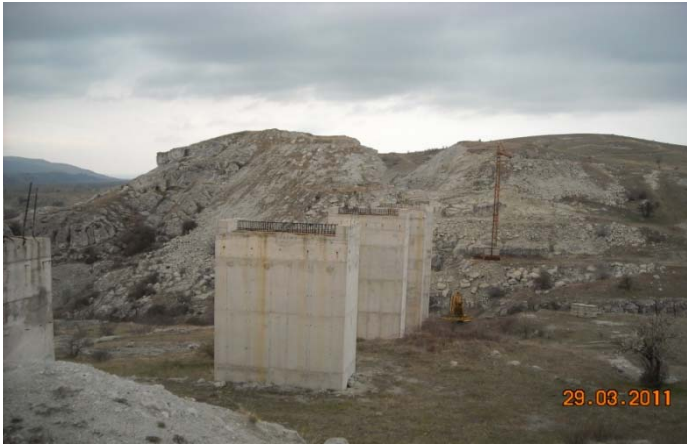
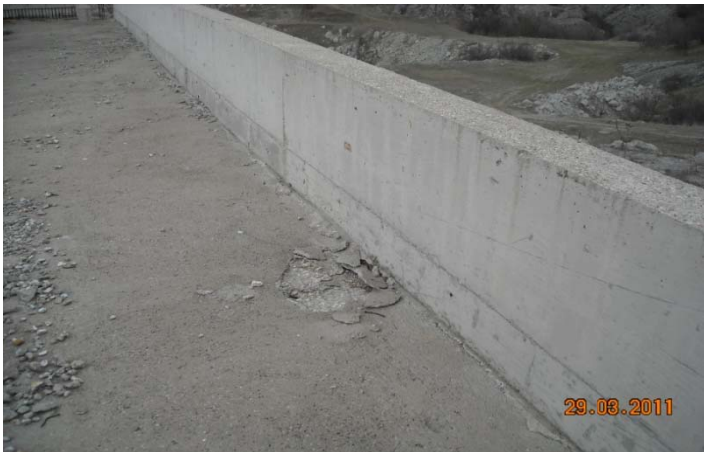
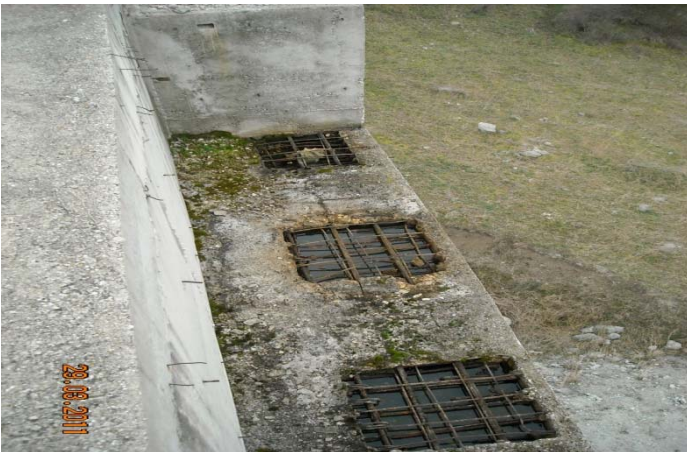
No	ELEMENT	CONDITION CLASS	DEFECTS DESCRIPTION	MEASURES
1	Abutments	2	1. constructed 8th oval abutment, 1st not constructed) 2. surface damage from ice	to protect the concrete surfaces
2	Piers	2	1. pier number 4, 5, 6 and 7 are completely constructed 2. 2th only one kampada finish, reinforced anchors are corrode and 50% cut 3. corrode reinforcement on parapets	to protect the reinforcement
3	Deck		not constructed	
4	Culvert		not constructed	
5	Bearing areas		not constructed	
6	Main Girders/Beams		not constructed	
7	Cross Girders		not constructed	
7	Expansion joints		not constructed	
8	Drainage system		not constructed	
9	Level of Completion (%)		1. SUBSTRUCTURE 65% SUPERSTRUCTURE 0%	2.
10	Designing		Main Project

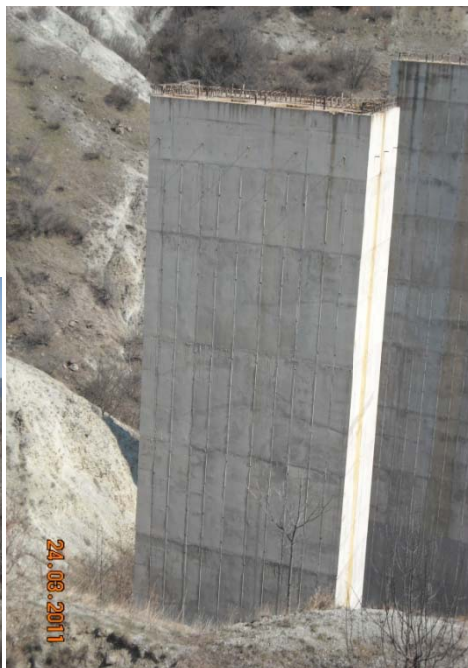
No	ELEMENT	CONDITION CLASS	DEFECTS DESCRIPTION	MEASURES
1	Abutments	1	2 oval abutment with parallel wings are constructed (no visual defects)	
2	Piers	1	1 pier completely constructed (no visual defects)	
3	Deck		not constructed	
4	Culvert		not constructed	
5	Bearing areas		not constructed	
6	Main Girders/Beams		not constructed	
7	Cross Girders		not constructed	
7	Expansion joints		not constructed	
8	Drainage system		not constructed	
9	Level of Completion (%)		1. SUBSTRUCTURE 100% 2. SUPERSTRUCTURE 0%	
10	Designing		Main Project

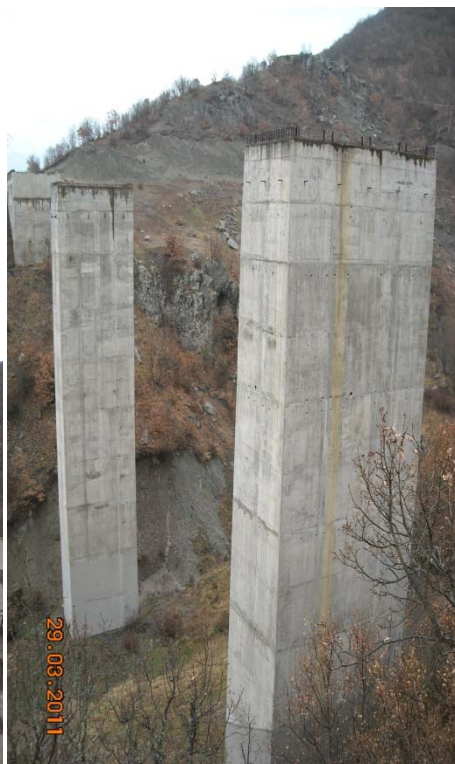
No	ELEMENT	CONDITION CLASS	DEFECTS DESCRIPTION	MEASURES
1	Abutments	2	1. 2 oval abutment with parallel wings are constructed 2. corrode and cut reinforcement from parapets	to protect reinforcement against corrosion
2	Piers	1	12 piers constructed (no visual defects)	
3	Deck		not constructed	to construct immediately
4	Culvert		not constructed	
5	Bearing areas	1	installed 56 bearings	
6	Main Girders/Beams	1	1. 44 beams are constructed 2. 28 beams are prestressed and installed (they need to be loaded immediately or Pavement should be constructed) 3. 16 beams should be prestress, install and load 4. They have an increased deflection	to protect the dowel from corrosion
7	Cross Girders	1	1. 7x2=14 end cross girders are constructed 2. 2 middle cross girders are constructed on Field 7	to construct the middle cross girders
7	Expansion joints		not constructed	
8	Drainage system		not constructed	
9	Level of Completion (%)		1. SUBSTRUCTURE 100% 2. SUPERSTRUCTURE 65%

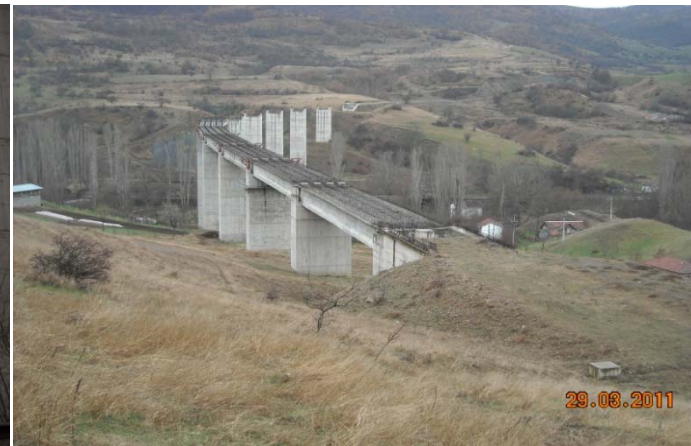
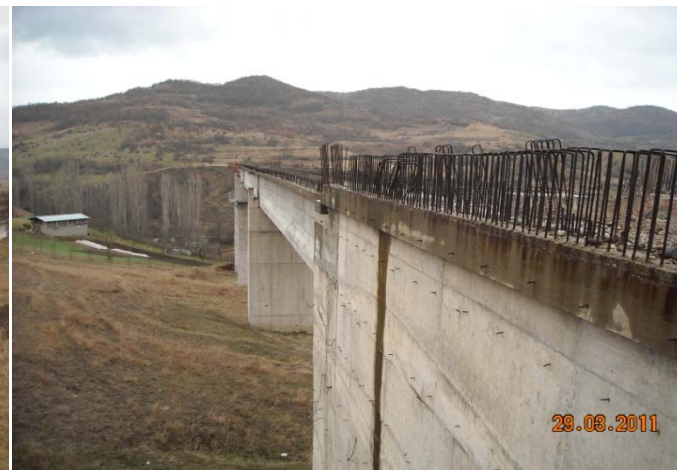
No	ELEMENT	CONDITION CLASS	DEFECTS DESCRIPTION	MEASURES
1	Abutments	1	2 oval abutment with parallel wings are constructed [no visual defects]	
2	Piers	1	4 piers constructed [no visual defects]	
3	Deck	1	constructed [no visual defects]	
4	Culvert	1	pipes are placed in bridge deck and dewatering is solved	
5	Bearing areas	1	all bearings are installed [no visual defects]	
6	Main Girders/Beams	1	20 beams are constructed [no visual defects]	
7	Cross Girders	1	10 end cross girders and 10 middle cross girders are constructed [no visual defects]	
7	Expansion joints		not installed [see photo No.]	to install immediately
8	Drainage system		not constructed	
9	Level of Completion [%]		1. SUBSTRUCTURE 100% 2. SUPERSTRUCTURE 90%	
10	Designing		Main Project

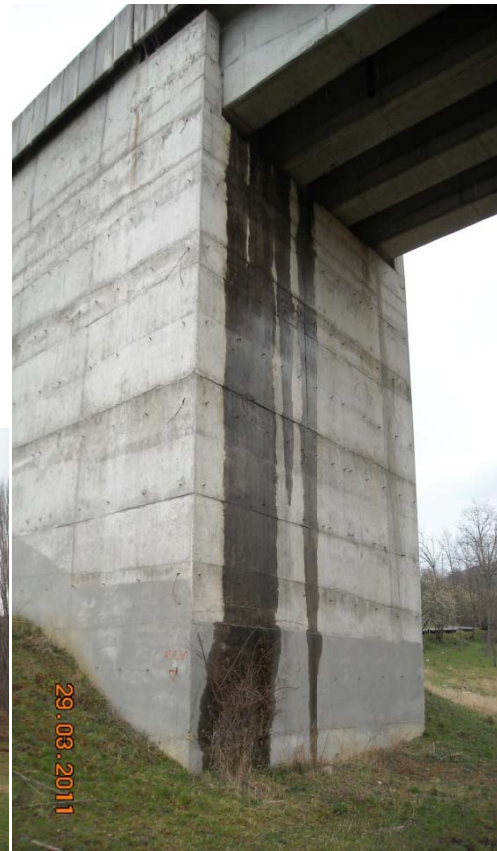
No	ELEMENT	CONDITION CLASS	DEFECTS DESCRIPTION	MEASURES
1	Abutments	2	parapets reinforcement corrode and cut in several places	to protect reinforcement
2	Piers	1	4 piers constructed ☐no visual defects☐	
3	Deck		not constructed	
4	Culvert		not constructed	
5	Bearing areas		not constructed	
6	Main ☐irders/Beams	3	20 beams are constructed ☐8 of 20 beams are fallen☐	to repair end install
7	Cross ☐irders		not constructed	
7	E☐ansion joints		not constructed	
8	Drainage system		not constructed	
9	☐evel of Completion ☐☐		1. S☐BSTR☐CT☐RE 100☐ 2. S☐PERSTR☐CT☐RE 50☐	
10	Designing		Main Project

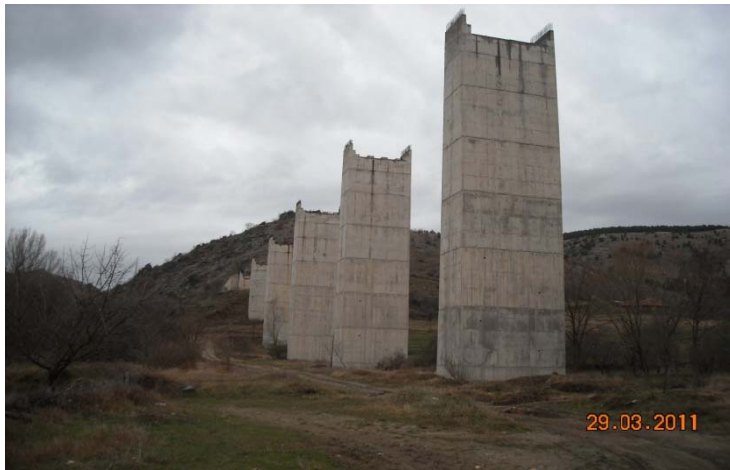
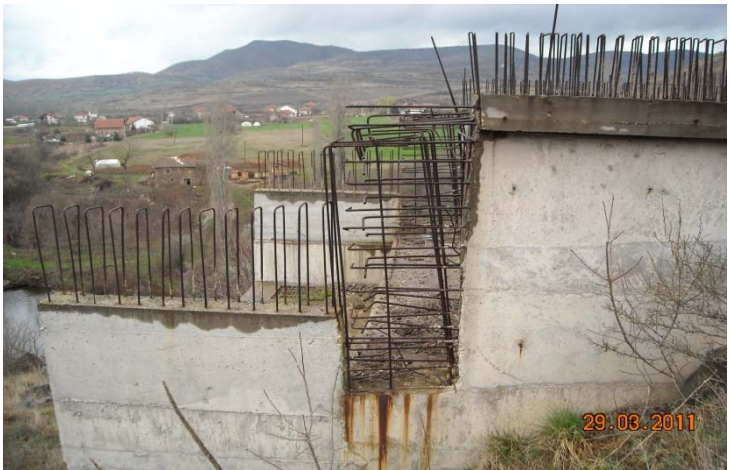
No	ELEMENT	CONDITION CLASS	DEFECTS DESCRIPTION	MEASURES
1	Abutments	2	1. 2 oval abutment with parallel wings are constructed to finish wedge fill on 2th abutment 2. corrode reinforcement from parapets	to protect reinforcement
2	Piers	1	5 piers constructed no visual defects	
3	Deck		not constructed	
4	Culvert		not constructed	
5	Bearing areas		not constructed	
6	Main girders/Beams		not constructed	
7	Cross girders		not constructed	
7	Expansion joints		not constructed	
8	Drainage system		not constructed	
9	Level of Completion		1. SUBSTRUCTURE 100% 2. SUPERSTRUCTURE 0%	
10	Designing		Main Project

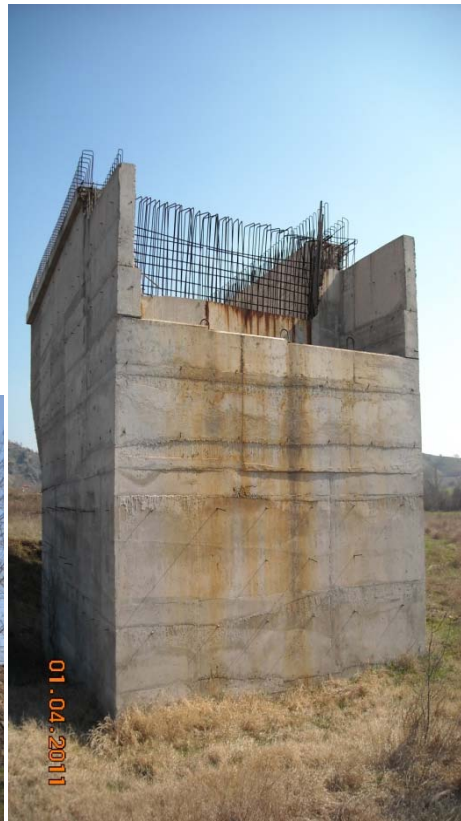
No	ELEMENT	CONDITION CLASS	DEFECTS DESCRIPTION	MEASURES
1	Abutments	2	2 oval abutment with parallel wings are constructed [no visual defects]	
2	Piers	1	2 piers constructed [no visual defects]	
3	Deck	2	it has surface damage from ice	
4	Culvert	1	pipes are placed in bridge deck and dewatering is solved	
5	Bearing areas	1	all bearings are installed [no visual defects]	
6	Main girders/Beams	1	3x4x12 beams [prestressed] are constructed and install [no visual defects]	
7	Cross girders	1	6 end cross girders and 6 middle cross girders are construct [no visual defects]	
7	Expansion joints		not installed	to install immediately
8	Drainage system		not constructed	
9	Level of Completion [] []		1. SUBSTRUCTURE 100% 2. SUPERSTRUCTURE 90%	
10	Designing		Main Project

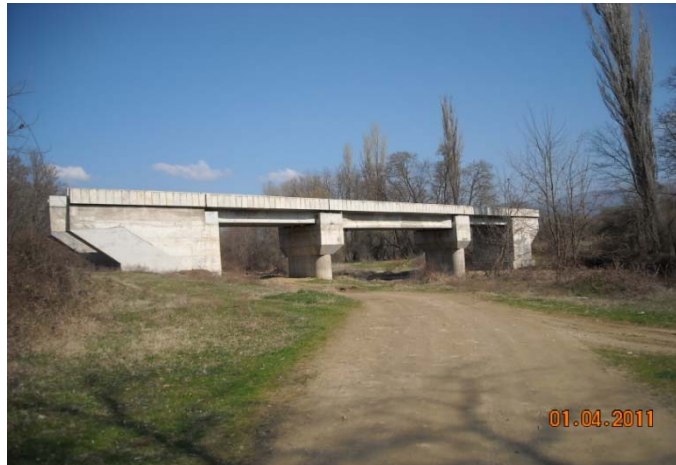
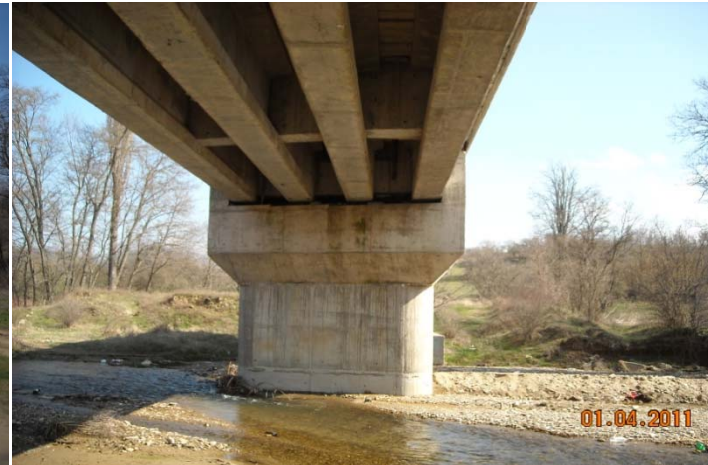
No	ELEMENT	CONDITION CLASS	DEFECTS DESCRIPTION	MEASURES
1	Abutments	1	2 oval abutment with parallel wings are constructed the 2th abutment has cracked wing	to repair the cracked wing
2	Piers	1	5 piers constructed no visual defects	
3	Deck	1	constructed no visual defects	
4	Culvert		pipes are placed in bridge deck and dewatering is solved	
5	Bearing areas	1	no visual defects	
6	Main girders/Beams	1	24 beams are construct and installed no visual defects	
7	Cross girders	1	6 2 12 end cross girders and 12 middle cross girders are construct no visual defects	
7	Expansion joints		not installed	dilatation joints to be set immediately
8	Drainage system		not constructed	
9	Level of Completion		1. SUBSTRUCTURE 100 2. SUPERSTRUCTURE 90	
10	Designing		Main Project

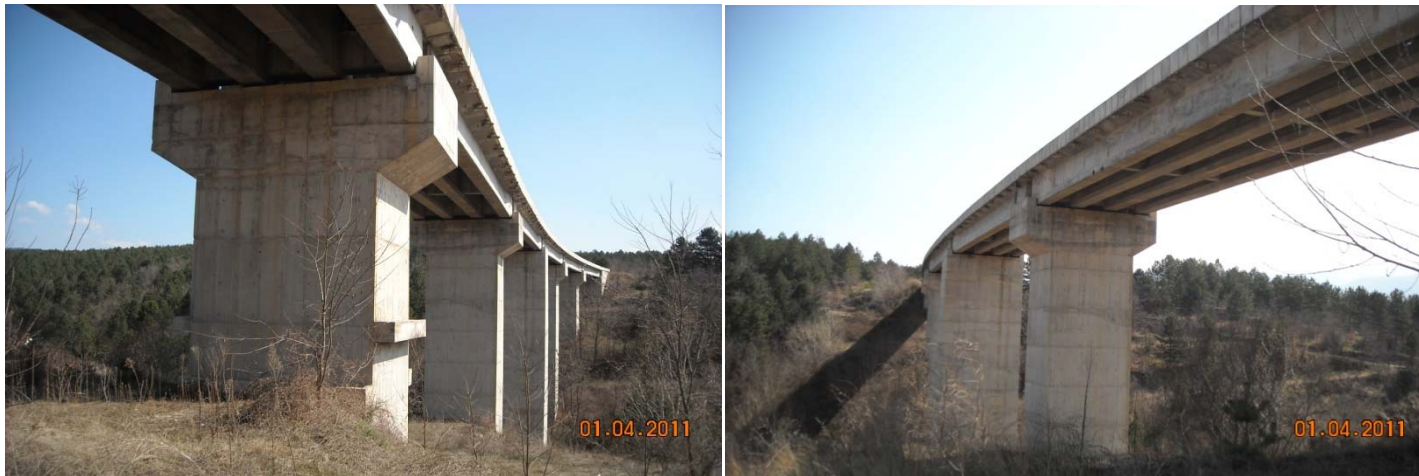
No	ELEMENT	CONDITION CLASS	DEFECTS DESCRIPTION	MEASURES
1	Abutments	1	2 oval abutment with parallel wings are constructed [no visual defects]	
2	Piers	1	3 piers constructed [no visual defects]	
3	Deck	1	constructed [no visual defects]	
4	Culvert		pipes are placed in bridge deck and dewatering is solved	
5	Bearing areas	1	[no visual defects]	
6	Main girders/Beams	1	16 beams are construct and installed [no visual defects]	
7	Cross girders	1	4 28 end cross girders and 8 middle cross girders are construct [no visual defects]	
7	Expansion joints		not installed	to install immediately
8	Drainage system		not constructed	
9	Level of Completion []		1. SUBSTRUCTURE 100 2. SUPERSTRUCTURE 90	
10	Designing		Main Project

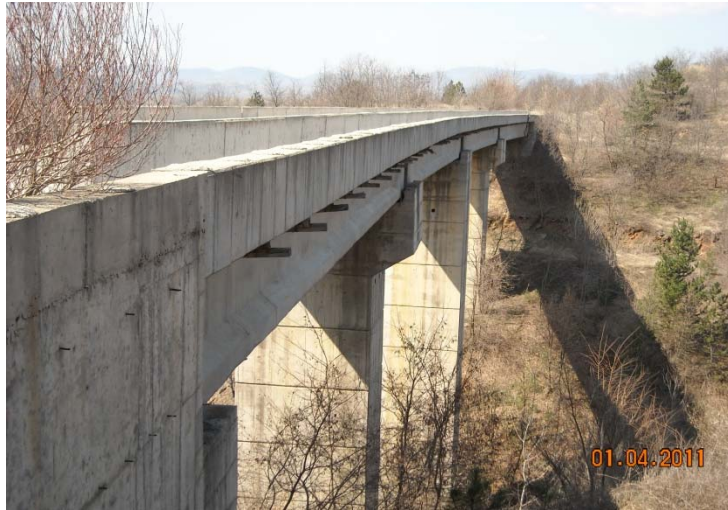
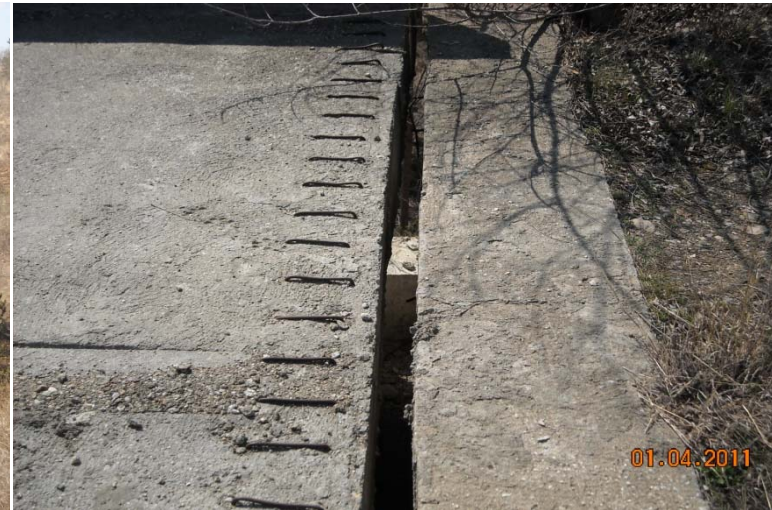
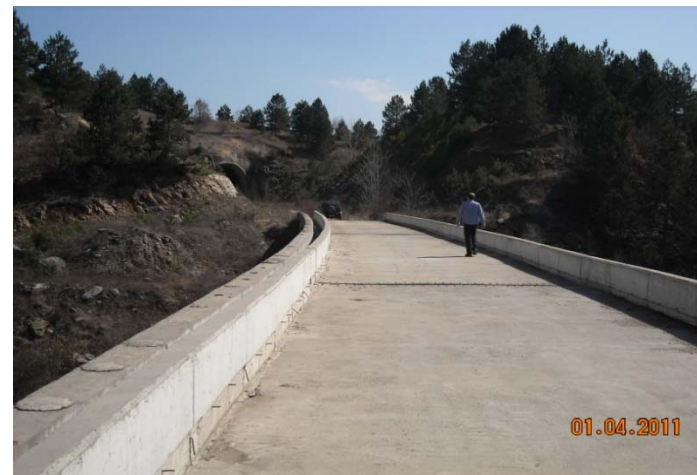
No	ELEMENT	CONDITION CLASS	DEFECTS DESCRIPTION	MEASURES
1	Abutments	1	2 oval abutment with parallel wings are constructed [no visual defects]	
2	Piers	2	segregation of lying beam parapets	cracks to be repair
3	Deck	1	constructed [no visual defects]	
4	Culvert		pipes are placed in bridge deck and dewatering is solved	
5	Bearing areas	1	[no visual defects]	
6	Main Girders/Beams	1	12 beams are construct and installed [no visual defects]	
7	Cross Girders	1	6 end cross girders and 6 middle cross girders are construct [no visual defects]	
7	Expansion joints		not installed	to install immediately
8	Drainage system		not constructed	
9	Level of Completion []		1. SUBSTRUCTURE 100% 2. SUPERSTRUCTURE 90%	
10	Designing		Main Project

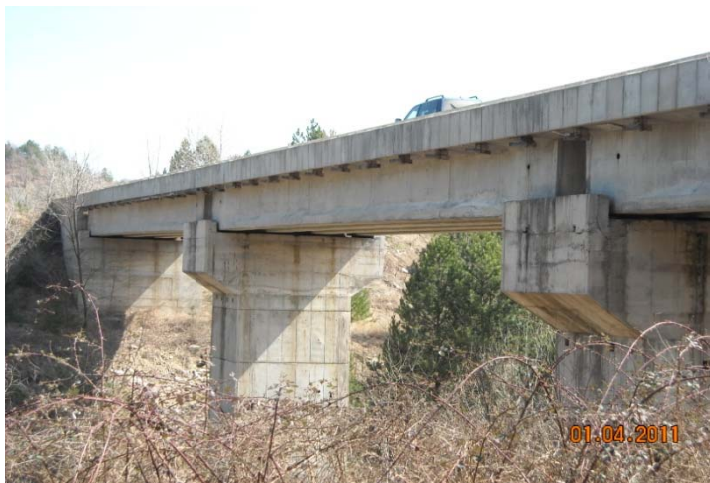
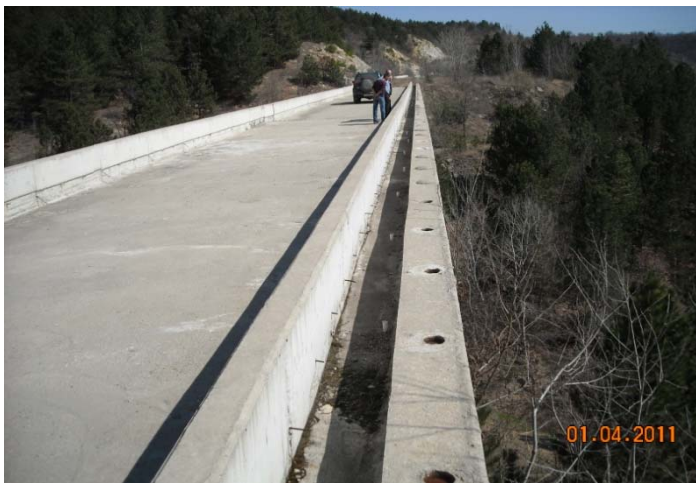
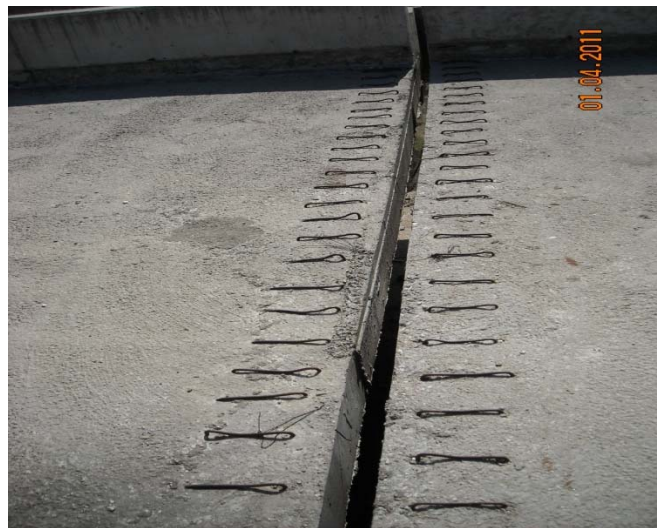
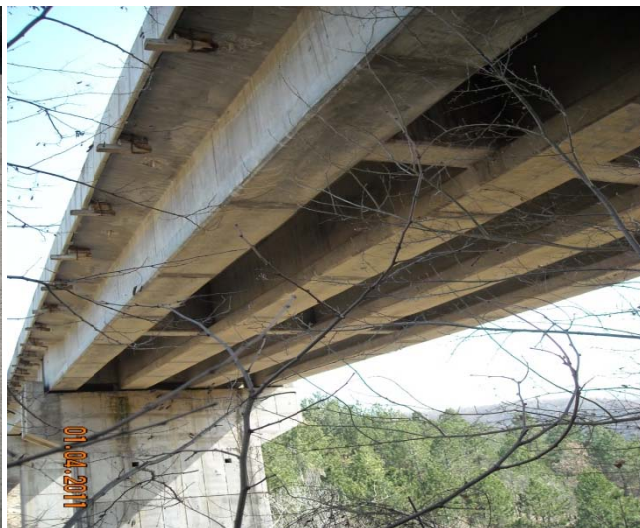
No	ELEMENT	CONDITION CLASS	DEFECTS DESCRIPTION	MEASURES
1	Abutments	2	2 oval abutment with parallel wings are constructed [no visual defects]	to remove the trees from wedges
2	Piers	1	2 piers are constructed [no visual defects]	
3	Deck	1	constructed [no visual defects]	
4	Culvert		pipes are placed in bridge deck and dewatering is solved	
5	Bearing areas	1	[no visual defects]	
6	Main girders/Beams	1	12 beams are construct and installed [no visual defects]	
7	Cross girders	1	6 end cross girders and 6 middle cross girders are construct [no visual defects]	
7	Expansion joints		not installed	to install immediately
8	Drainage system		not constructed	
9	Level of Completion []		1. SUBSTRUCTURE 100% 2. SUPERSTRUCTURE 90%	
10	Designing		Main Project

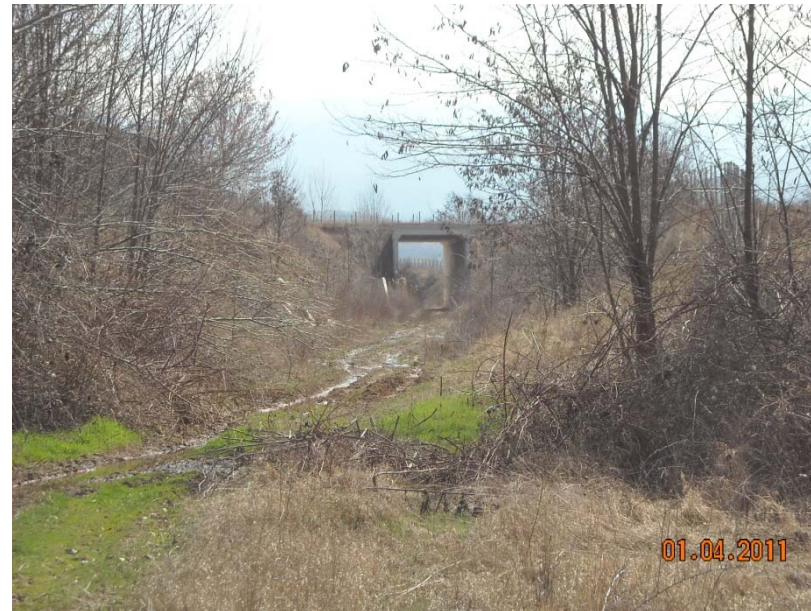
No	ELEMENT	CONDITION CLASS	DEFECTS DESCRIPTION	MEASURES
1	Cave - in	2	Due to undulating surface on site, works on bearing plate are stopped Tunnel is fully drilled /drilled/ with primary tunnel lining done	Reinforced bearing plate to be done
2	Portal /faults in concrete/	2	Construction works at the exit portal approaching cutting on the left side are stopped	To make sanction with concrete inject and hanger with anchors
3	Water leakage		Is not done	
4	Erosion		There is no visual erosion	
5	Slope Protection		Part from right side at the exit approach cutting is unstable	Sanction to be done
6	Drainage system		Is not done	
7	Level of Completion [] []			
8	Designing		There is a project	
			1 Entrance/exit approach cutting is made with concrete inject and anchors	
			2 Tunnel is drilled /drilled/ with done primary tunnel lining	
			3 Bearing plate /tie-plate/ is 100% done

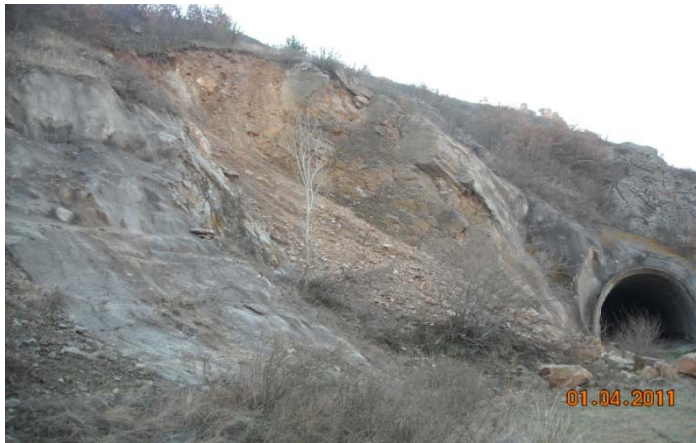
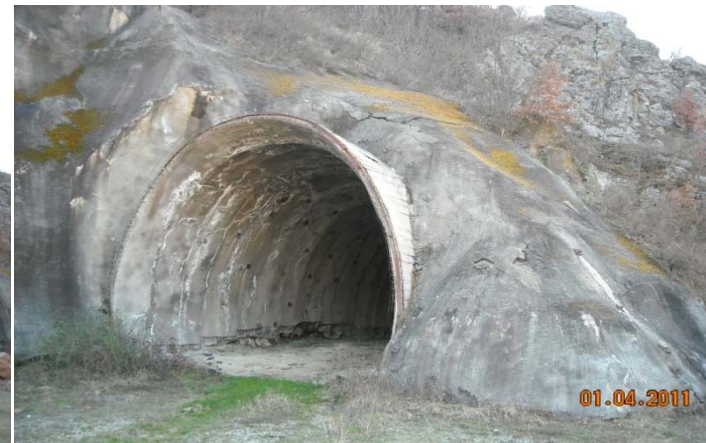
No	ELEMENT	CONDITION CLASS	DEFECTS DESCRIPTION	MEASURES
1	Cave - in	2	Primary tunnel lining is loosen, tunnel has been drilled 40-45m and primary tunnel lining is done	Sanction to be done
2	Portal - faults in concrete	2	Entrance portal approach cutting is done and concrete inject with anchors	
3	Water leakage		There is water at the entrance of the tunnel	Dewatering to be solved
4	Erosion		In nipper from primary tunnel lining	
5	Slope Protection		No visual defects	Sanction to be done
6	Drainage system		Is not done	
7	Level of Completion			
8	Designing		There is a project	
9			1 - Entrance approach cutting is done, concrete inject and anchors	
10			2 - Tunnel is driven 8 - and primary tunnel lining is done	
11			3 - Bearing plate has not been started
