This supplementary Site Inspection Record for existing structures presents the Consultant's findings in respect of all the bridges and tunnels on the project railway line from Kumanovo to Bulgarian border. This report is additional to the requirements of the Terms of Reference and Task 4 Development of Preferred Alternative for the Feasibility Study. This report summarises the research into the condition of the bridges and tunnels and is used for consequential costs for their construction or finalisation.

BRIDGE INSPECTION RECORD (NO ACCESS TO THE OBJECT)							
Bridge		Bridge No.	length	width	chainage	Bridge type	Date of Inspection
Section	MAVROVO 37+624 - 44+390	7	2X25 (50m)	6.5m	km 40+014.00	RC Viaduct	29.03.2011

BRIDGE INSPECTION RECORD							
Bridge		Bridge No.	length	width	chainage	Bridge type	Date of Inspection
Section	GRANIT 44+390 - 55+500	12	13X36 (468m)	6.5m	km 46+068.00	RC Viaduct	29.03.2011

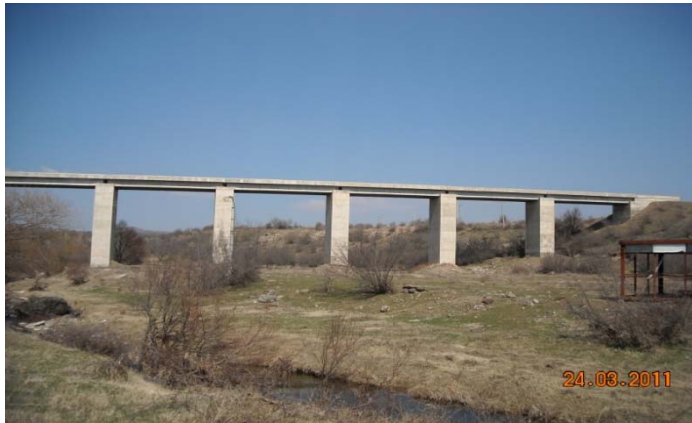
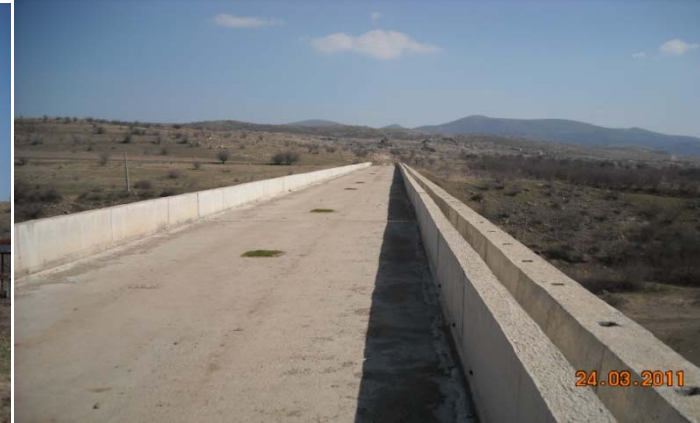
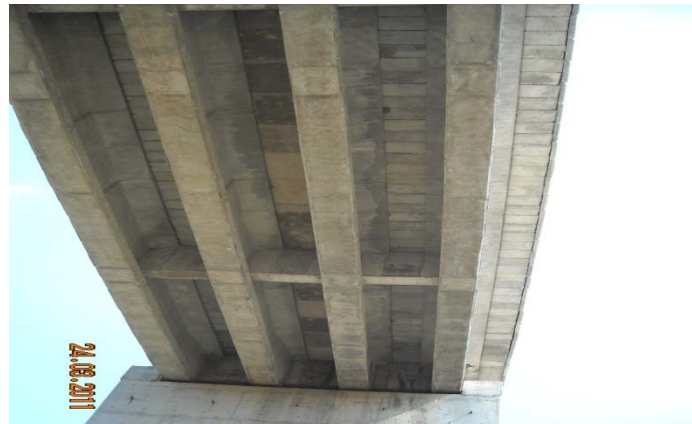
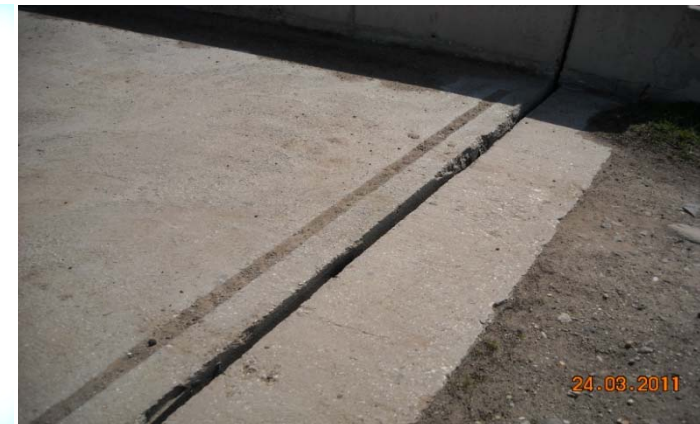
No	ELEMENT	CONDITION CLASS	DEFECTS DESCRIPTION	MEASURES
1	Abutments	1	(2 oval abutments with parallel wings) no visual defects	
2	Piers	1	(7 piers) no visual defects	
3	Deck	2	appearance of small surface damage from external influences	to make protection on pavement
4	Culvert		not constructed (only holes are done)	to make safe drainage to the terrain
5	Bearing areas	2	water from pavement (bearing areas not secure and there is no dilatations)	to make dilatation to prevent water infiltration
6	Main Girders/Beams	1	L=20m, 32, (constructed and installed) no visual defects	
7	Cross Girders	2	4x8=32, 16 end, 16 middle (they are not in straight)	no measures
7	Expansion joints		not constructed	to be construct for preventing the water infiltration
8	Drainage system		not constructed	
9	Level of Completion (%)		1. SUBSTRUCTURE 100% 2. SUPERSTRUCTURE 90%	
10	Designing		Main Project

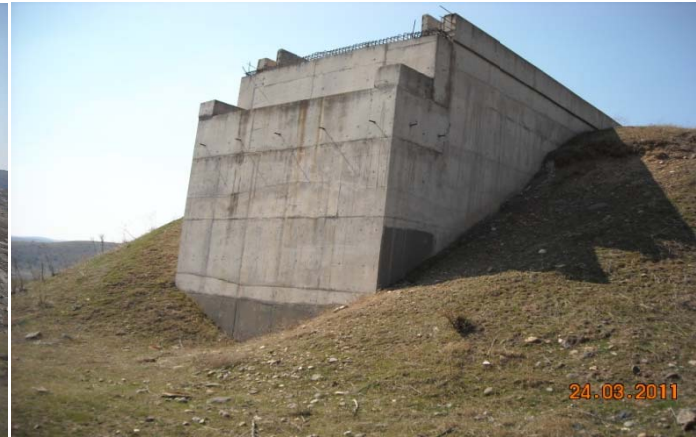
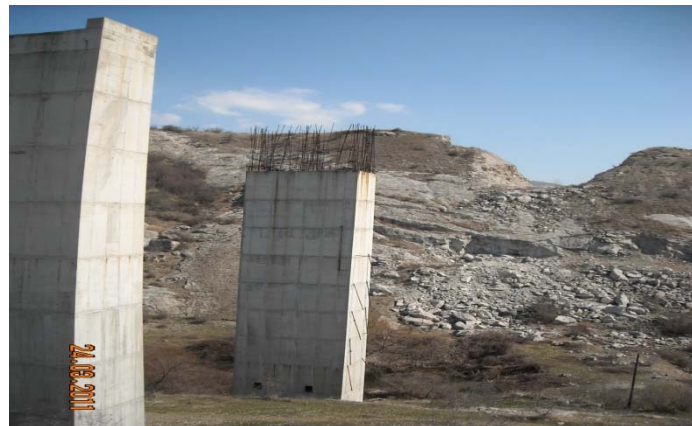
Bridge		Bridge No.	length	width	chainage	Bridge type	Date of Inspection
Section	BETON 29+000 - 37+624	2	8X25 (200m)	6.5m	km 35+996.00	RC Viaduct	24.03.2011

No	ELEMENT	CONDITION CLASS	DEFECTS DESCRIPTION	MEASURES
1	Abutments	1	(constructed 1st oval abutment, 8th not constructed) no visual defects	
2	Piers	2	(3 piers completely constructed, on 5th pier miss kampada, 6th and 7th not constructed) corrode reinfor.	to clean reinforcement if the intersection is not damage
3	Deck		not constructed	
4	Culvert		not constructed	
5	Bearing areas		not constructed	
6	Main Girders/Beams		not constructed	
7	Cross Girders		not constructed	
7	Expansion joints		not constructed	
8	Drainage system		not constructed	
9	Level of Completion (%)		1. SUBSTRUCTURE 65% SUPERSTRUCTURE 0%	2.
10	Designing		Main Project

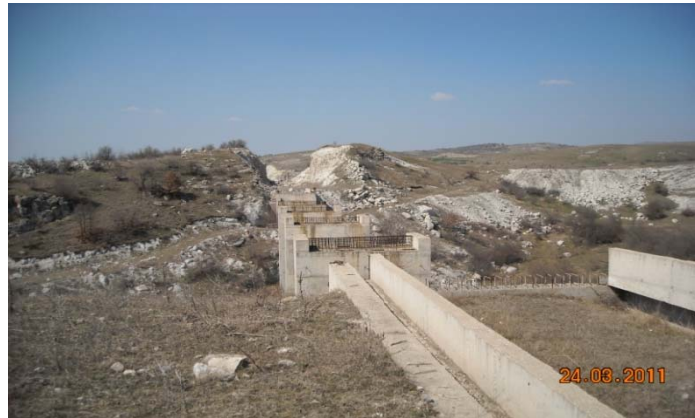
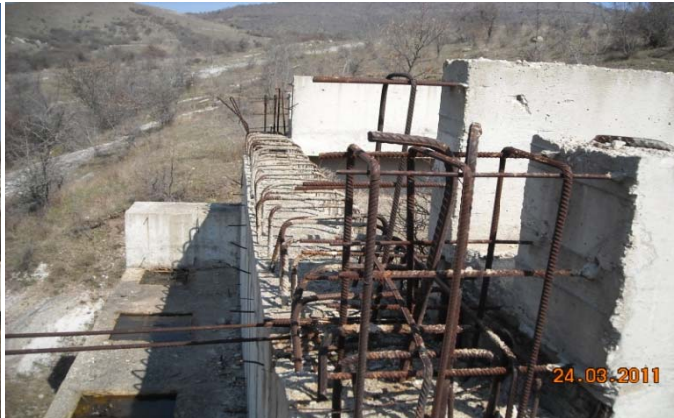
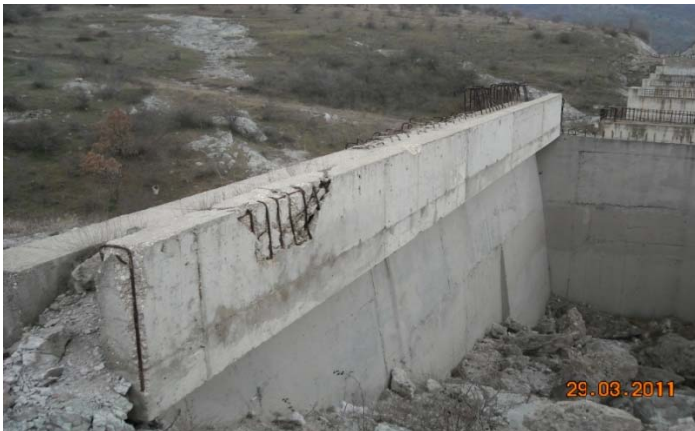
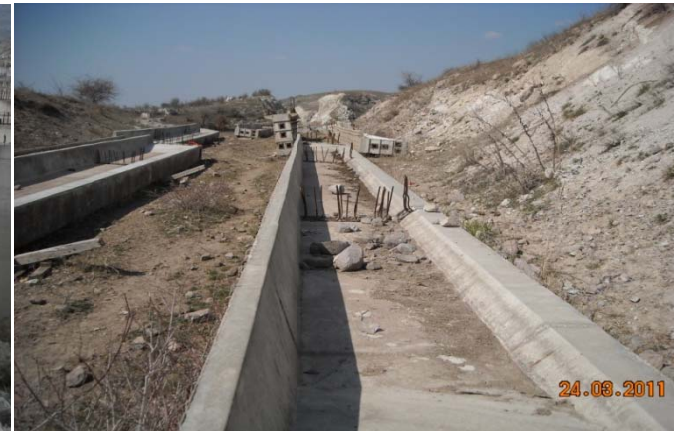
No	ELEMENT	CONDITION CLASS	DEFECTS DESCRIPTION	MEASURES
1	Abutments	2	1. constructed 2 oval abutment with parallel wings 2. damaged parapets from wings on 1st oval abutment 3. corrode reinforcement on bearing areas	to protect the reinforcement
2	Piers	2	1. corrode reinforcement from beam parapets 2. 4 piers completely constructed	to protect the reinforcement
3	Deck		not constructed	
4	Culvert		not constructed	
5	Bearing areas		not constructed	
6	Main Girders/Beams	4	1. 20 (5x4) beams are constructed 2. 16 beams are fallen and cracks are occurred 3. 4 beams are upright but in bad condition 4. reinforcement, plocki od kotvi za prednaprejanje and box for bearings are corrode 5. They are not prestressed	to do rehabilitation, prestress and instalation
7	Cross Girders		not constructed	
7	Expansion joints		not constructed	
8	Drainage system		not constructed	
9	Level of Completion (%)		1. SUBSTRUCTURE 100% 2. SUPERSTRUCTURE 60%

Additional Measures:

To take immediate measures to protect the main beams

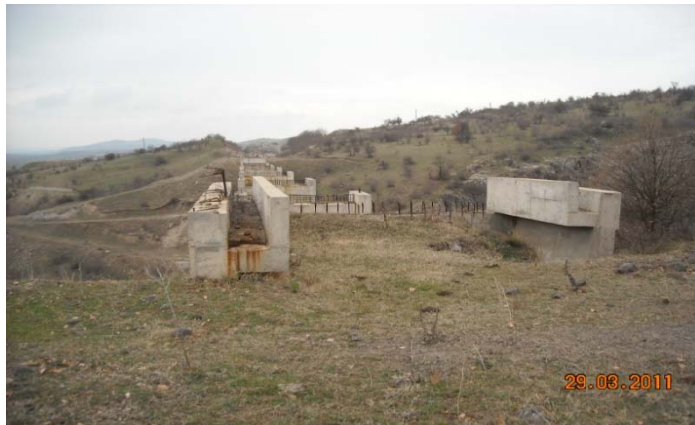
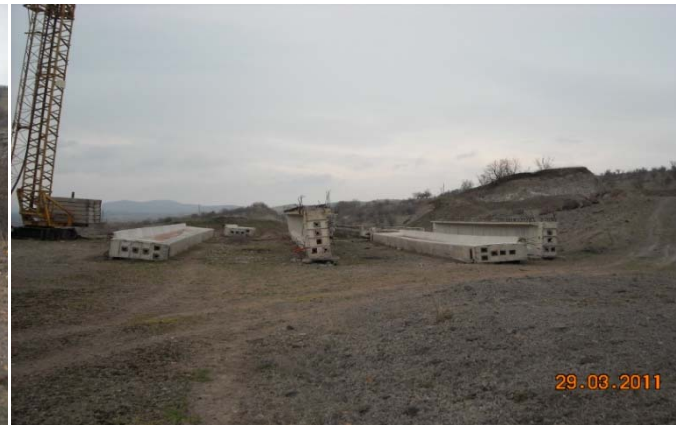
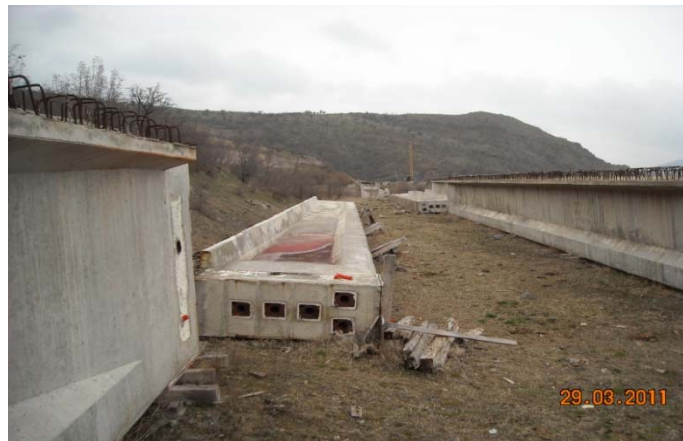
BRIDGE INSPECTION RECORD							
Bridge		Bridge No.	length	width	chainage	Bridge type	Date of Inspection
Section	BETON 29+000 - 37+624	5	2x20,5x25 (165m)	6.5m	km 37+604.00	RC Viaduct	29.03.2011

No	ELEMENT	CONDITION CLASS	DEFECTS DESCRIPTION	MEASURES
1	Abutments	2	2 oval abutment with parallel wings are constructed (no visual defects)	
2	Piers	1	6 piers constructed (no visual defects)	
3	Deck		not constructed	
4	Culvert		not constructed	
5	Bearing areas		bearings are not set	
6	Main Girders/Beams	4	1. 19 of 28 beams are constructed beams are fallen and cracks are occurred beams are upright but in bad condition reinforcement and box for bearings are corrode 5. They are not prestressed	2. 9 3. 4 4. to do rehabilitation, prestress and instalation
7	Cross Girders		not constructed	
7	Expansion joints		not constructed	
8	Drainage system		not constructed	
9	Level of Completion (%)		1. SUBSTRUCTURE 100% SUPERSTRUCTURE 50%	2.
10	Designing		Main Project

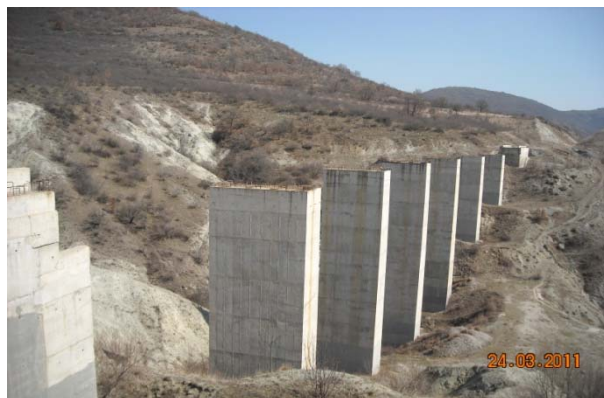
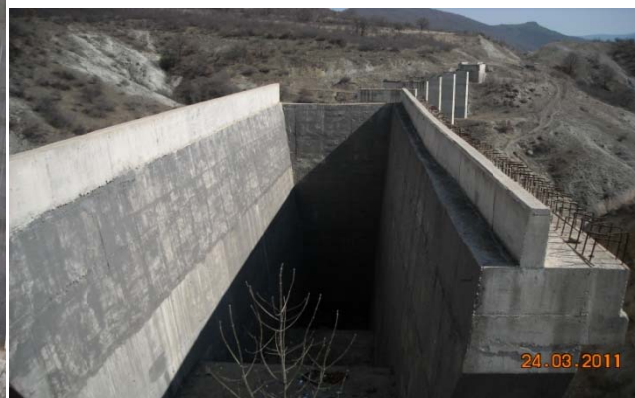
BRIDGE INSPECTION RECORD							
Bridge		Bridge No.	length	width	chainage	Bridge type	Date of Inspection
Section	MAVROVO 37+624 - 44+390	6	7X25 (175m)	6.5m	km 39+560.00	RC Viaduct	29.03.2011

No	ELEMENT	CONDITION CLASS	DEFECTS DESCRIPTION	MEASURES
1	Abutments	2	1. 2 oval abutment with parallel wings are constructed (no visual defects)	
2	Piers	1	1. 6 piers completely constructed 2. parapet reinforcement from bearing beams is corrode	
3	Deck		not constructed	
4	Culvert		not constructed	
5	Bearing areas		not constructed	
6	Main Girders/Beams		not constructed	
7	Cross Girders		not constructed	
7	Expansion joints		not constructed	
8	Drainage system		not constructed	
9	Level of Completion (%)		1. SUBSTRUCTURE 100% 2. SUPERSTRUCTURE 0%	
10	Designing		Main Project

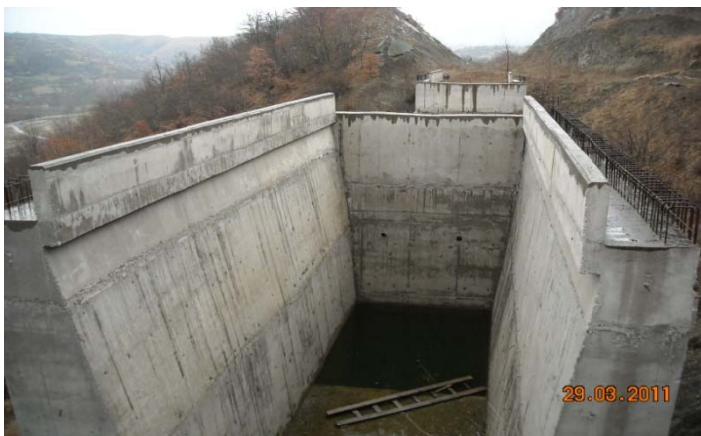
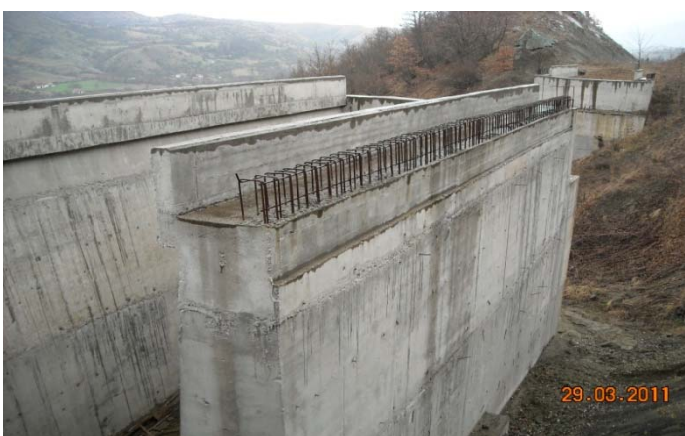
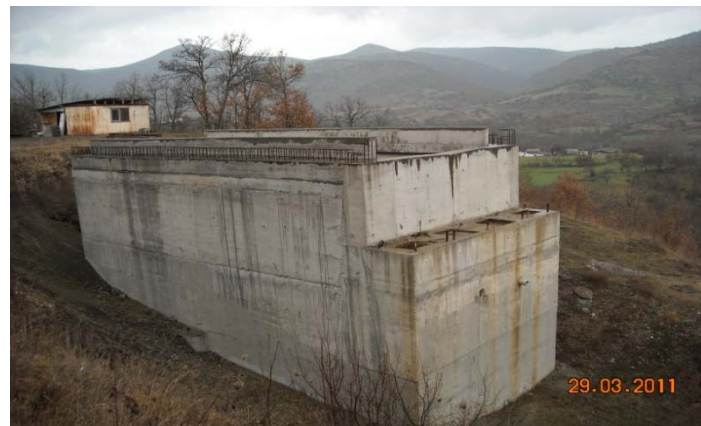
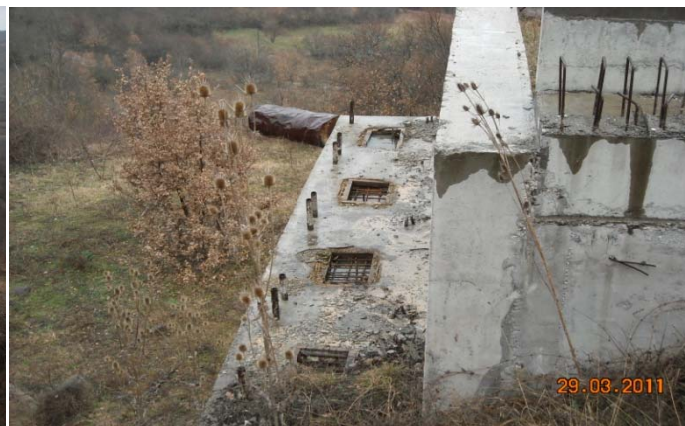
Bridge		Bridge No.	length	width	chainage	Bridge type	Date of Inspection
Section	MAKOVO 37+624 - 44+390	10	1X25 25m	6.5m	km 43+482.00	RC viaduct	29.03.2011

No	ELEMENT	CONDITION CLASS	DEFECTS DESCRIPTION	MEASURES
1	Abutments	2	2 oval abutment with parallel wings are constructed [no visual defects]	to protect corrode reinforcement
2	Piers		not constructed	
3	Deck		not constructed	
4	Culvert		not constructed	
5	Bearing areas		not constructed	
6	Main girders/Beams		not constructed	
7	Cross girders		not constructed	
7	Expansion joints		not constructed	
8	Drainage system		not constructed	
9	Level of Completion [] []		1. SUBSTRUCTURE 5% 2. SUPERSTRUCTURE 0%	
10	Designing		Main Project

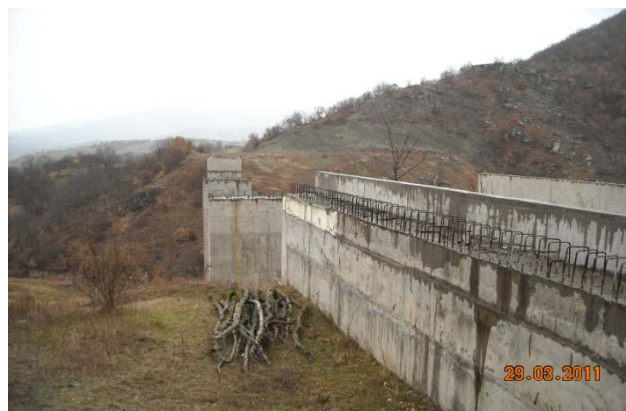
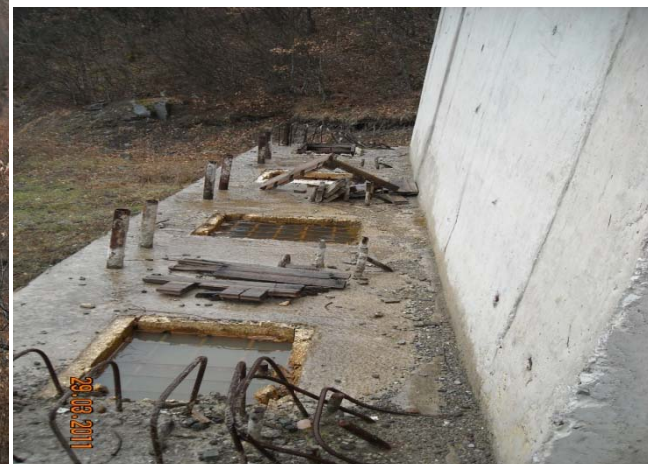
Bridge	Bridge No.	length	width	chainage	Bridge type	Date of Inspection	
Section	MAKOVO 37+624 - 44+390	11	3X35 x105m	6.5m	km 43+679.00	RC viaduct	29.03.2011

No	ELEMENT	CONDITION CLASS	DEFECTS DESCRIPTION	MEASURES
1	Abutments	2	2 oval abutment with parallel wings are constructed no visual defects	to protect corrode reinforcement
2	Piers	1	2 pier competly construct no visual defects	
3	Pavement		not constructed	
4	Culvert		not constructed	
5	Bearing areas		not constructed	
6	Main girders/Beams		not constructed	
7	Cross girders		not constructed	
7	Expansion joints		not constructed	
8	Drainage system		not constructed	
9	Level of Completion		1. SUBSTRUCTURE 100% 2. SUPERSTRUCTURE 0%	
10	Designing		Main Project

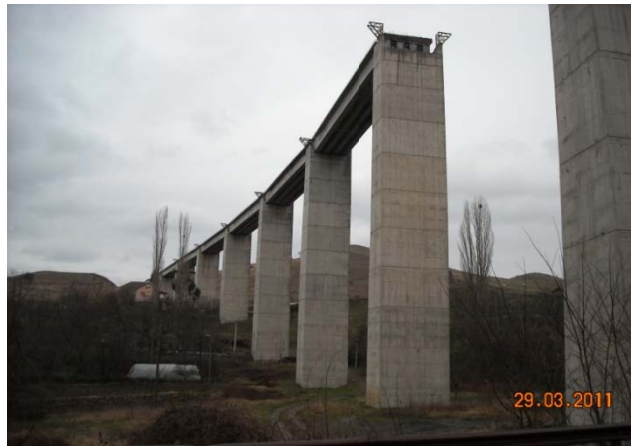
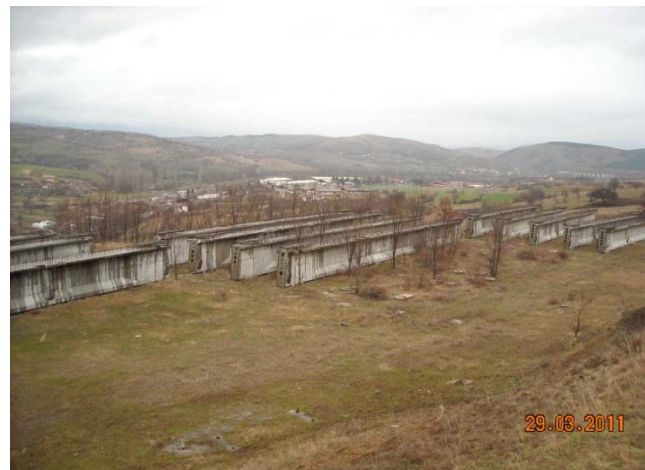
No	ELEMENT	CONDITION CLASS	DEFECTS DESCRIPTION	MEASURES
1	Abutments	2	1. 2 oval abutment with parallel wings are constructed 2. corrode and cut reinforcement from parapets	to protect reinforcement against corrosion
2	Piers	1	12 piers constructed (no visual defects)	
3	Deck		not constructed	to construct immediately
4	Culvert		not constructed	
5	Bearing areas	1	installed 56 bearings	
6	Main Girders/Beams	1	1. 44 beams are constructed 2. 28 beams are prestressed and installed (they need to be loaded immediately or Pavement should be constructed) 3. 16 beams should be prestress, install and load 4. They have an increased deflection	to protect the dowel from corrosion
7	Cross Girders	1	1. 7x2=14 end cross girders are constructed 2. 2 middle cross girders are constructed on Field 7	to construct the middle cross girders
7	Expansion joints		not constructed	
8	Drainage system		not constructed	
9	Level of Completion (%)		1. SUBSTRUCTURE 100% 2. SUPERSTRUCTURE 65%

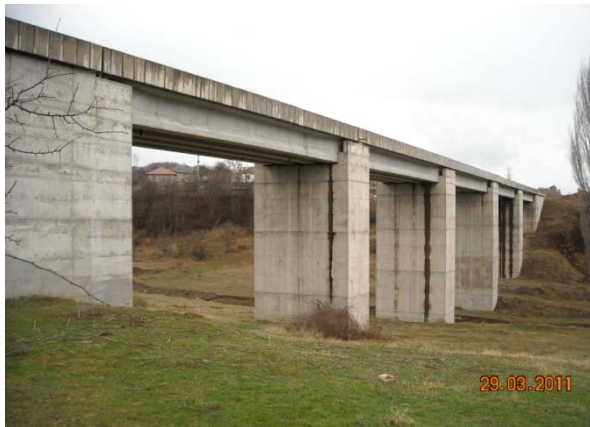
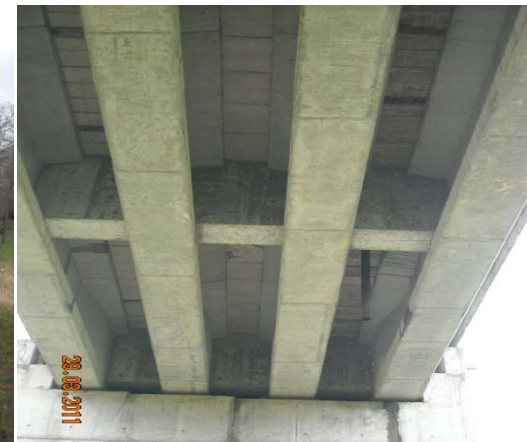
Bridge	Bridge No.	length	width	chainage	Bridge type	Date of Inspection
Section	BRANIT 44+390 - 55+500	13	5X20 [100m]	6.5m	km 48+280.00	RC [i]aduct

No	ELEMENT	CONDITION CLASS	DEFECTS DESCRIPTION	MEASURES
1	Abutments	1	2 oval abutment with parallel wings are constructed [no visual defects]	
2	Piers	1	4 piers constructed [no visual defects]	
3	Deck	1	constructed [no visual defects]	
4	Culvert	1	pipes are placed in bridge deck and dewatering is solved	
5	Bearing areas	1	all bearings are installed [no visual defects]	
6	Main Girders/Beams	1	20 beams are constructed [no visual defects]	
7	Cross Girders	1	10 end cross girders and 10 middle cross girders are constructed [no visual defects]	
7	Expansion joints		not installed [see photo No.]	to install immediately
8	Drainage system		not constructed	
9	Level of Completion [%]		1. SUBSTRUCTURE 100% 2. SUPERSTRUCTURE 90%	
10	Designing		Main Project

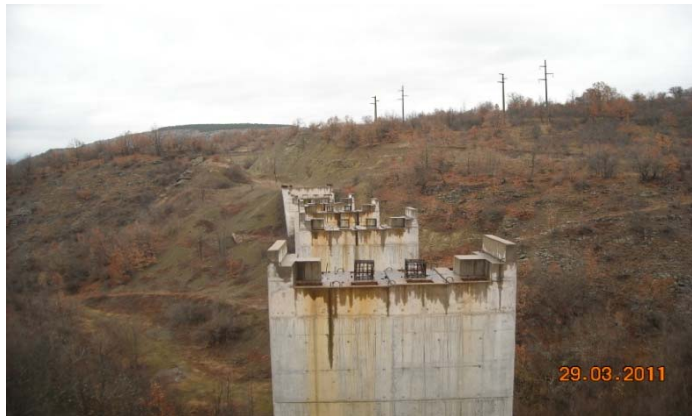
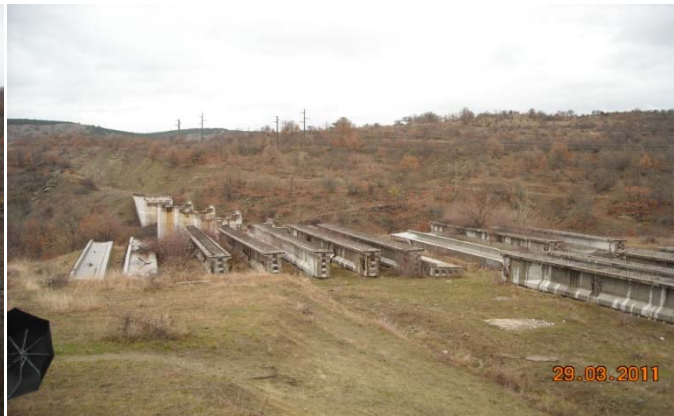
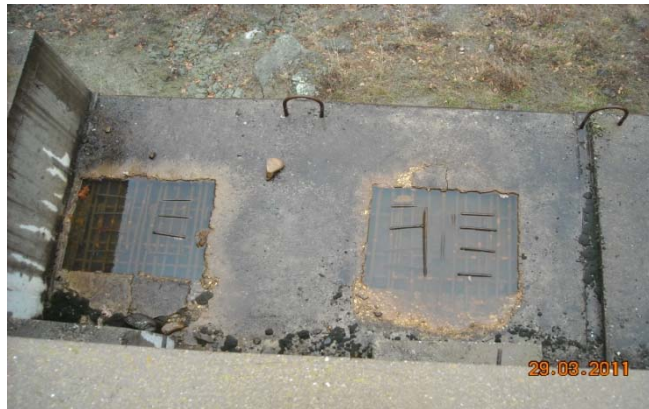
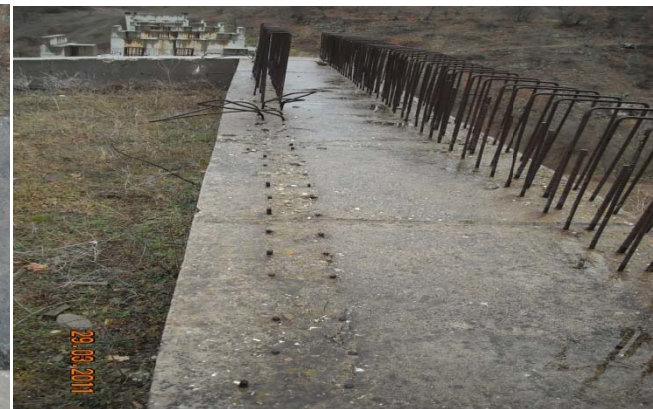
Bridge		Bridge No.	length	width	chainage	Bridge type	Date of Inspection
Section	☐RANIT 44+390 - 55+500	14	5X20 ☐100m☐	6.5m	km 48+803.00	RC ☐iaduct	29.03.2011

No	ELEMENT	CONDITION CLASS	DEFECTS DESCRIPTION	MEASURES
1	Abutments	2	parapets reinforcement corrode and cut in several places	to protect reinforcement
2	Piers	1	4 piers constructed ☐no visual defects☐	
3	Deck		not constructed	
4	Culvert		not constructed	
5	Bearing areas		not constructed	
6	Main ☐irders/Beams	3	20 beams are constructed ☐8 of 20 beams are fallen☐	to repair end install
7	Cross ☐irders		not constructed	
7	E☐ansion joints		not constructed	
8	Drainage system		not constructed	
9	☐evel of Completion ☐☐		1. S☐BSTR☐CT☐RE 100☐ 2. S☐PERSTR☐CT☐RE 50☐	
10	Designing		Main Project

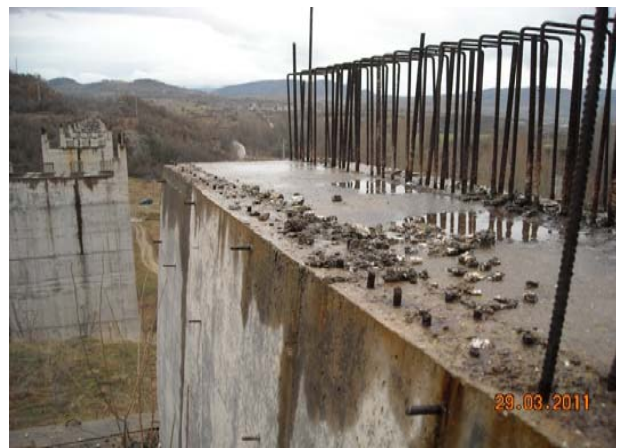
Bridge		Bridge No.	length	width	chainage	Bridge type	Date of Inspection
Section	BRANIT 44+390 - 55+500	14a	11X30 [330m]	6.5m	km 49+541.00	RC viaduct	29.03.2011

No	ELEMENT	CONDITION CLASS	DEFECTS DESCRIPTION	MEASURES
1	Abutments	3	1. 2 oval abutment with parallel wings are constructed [the parallel wing from 2th abutment continues with ret. wall] 2. corrode and cut reinforcement from parapets [there are breaks in concreting and corrode reinforcement]	to protect reinforcement
2	Piers	1	10 piers constructed [no visual defects]	
3	Deck		not constructed	
4	Culvert		not constructed	
5	Bearing areas		not constructed	
6	Main girders/Beams		not constructed	
7	Cross girders		not constructed	
7	Expansion joints		not constructed	
8	Drainage system		not constructed	
9	Level of Completion [%]		1. SUBSTRUCTURE 100% 2. SUPERSTRUCTURE 0%	
10	Designing		Main Project

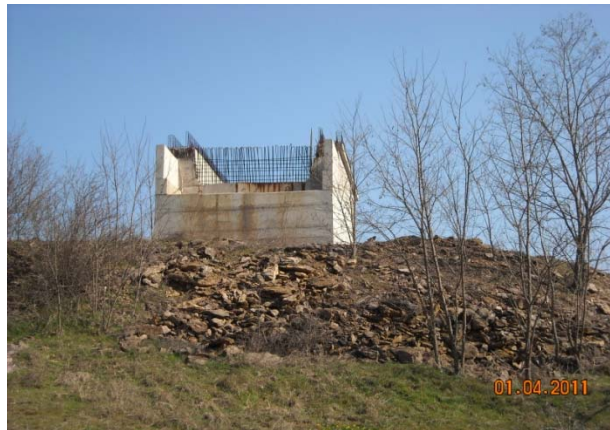
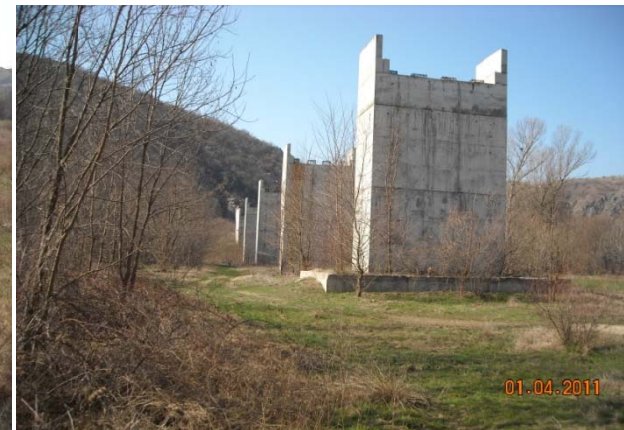
Bridge	Bridge No.	length	width	chainage	Bridge type	Date of Inspection
Section	BRANIT 44+390 - 55+500	15	6X30 m	6.5m	km 51+090.00	RC viaduct

No	ELEMENT	CONDITION CLASS	DEFECTS DESCRIPTION	MEASURES
1	Abutments	2	1. 2 oval abutment with parallel wings are constructed to finish wedge fill on 2th abutment 2. corrode reinforcement from parapets	to protect reinforcement
2	Piers	1	5 piers constructed no visual defects	
3	Deck		not constructed	
4	Culvert		not constructed	
5	Bearing areas		not constructed	
6	Main girders/Beams		not constructed	
7	Cross girders		not constructed	
7	Expansion joints		not constructed	
8	Drainage system		not constructed	
9	Level of Completion		1. SUBSTRUCTURE 100% 2. SUPERSTRUCTURE 0%	
10	Designing		Main Project

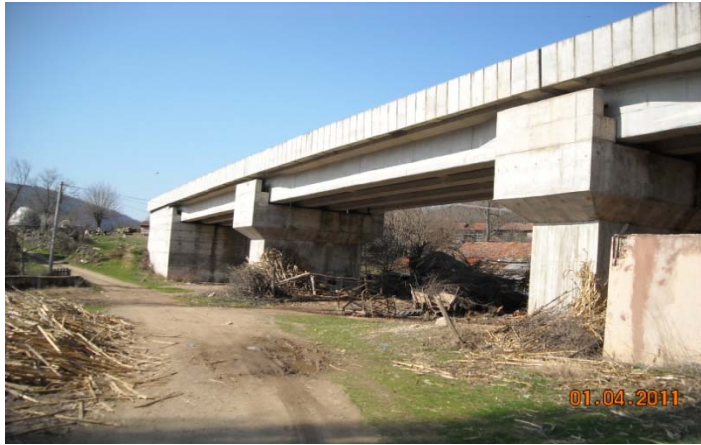
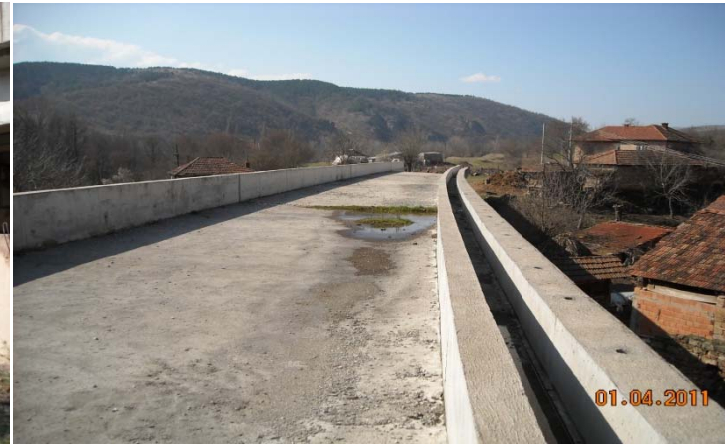
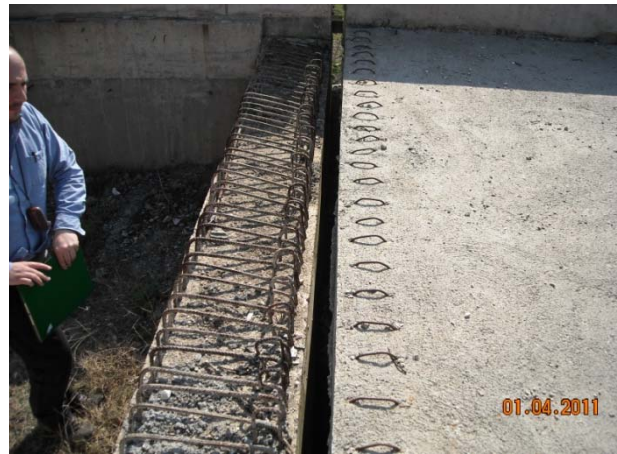
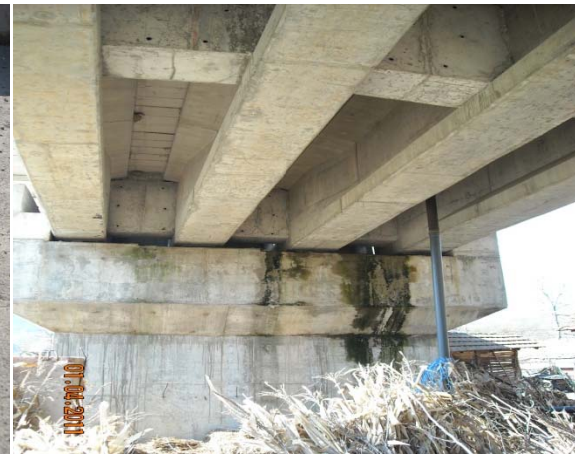
Bridge	Bridge No.	length	width	chainage	Bridge type	Date of Inspection	
Section	BRANIT 44+390 - 55+500	16	3X20 [60m]	6.5m	km 52+422.00	RC viaduct	01.04.2011

No	ELEMENT	CONDITION CLASS	DEFECTS DESCRIPTION	MEASURES
1	Abutments	2	2 oval abutment with parallel wings are constructed [no visual defects]	
2	Piers	1	2 piers constructed [no visual defects]	
3	Deck	2	it has surface damage from ice	
4	Culvert	1	pipes are placed in bridge deck and dewatering is solved	
5	Bearing areas	1	all bearings are installed [no visual defects]	
6	Main girders/Beams	1	3x4x12 beams [prestressed] are constructed and install [no visual defects]	
7	Cross girders	1	6 end cross girders and 6 middle cross girders are construct [no visual defects]	
7	Expansion joints		not installed	to install immediately
8	Drainage system		not constructed	
9	Level of Completion [] []		1. SUBSTRUCTURE 100% 2. SUPERSTRUCTURE 90%	
10	Designing		Main Project

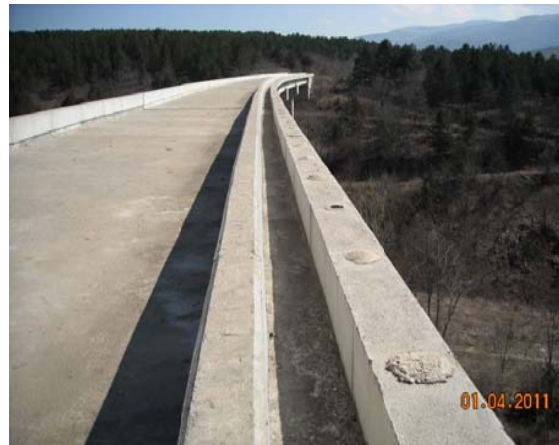
Bridge	Bridge No.	length	width	chainage	Bridge type	Date of Inspection
Section	PEAONI A 56+438 - 66+050	19	6X25 125m	6.5m	km 61+804.00	RC viaduct
						01.04.2011

No	ELEMENT	CONDITION CLASS	DEFECTS DESCRIPTION	MEASURES
1	Abutments	1	2 oval abutment with parallel wings are constructed the 2th abutment has cracked wing	to repair the cracked wing
2	Piers	1	5 piers constructed no visual defects	
3	Deck	1	constructed no visual defects	
4	Culvert		pipes are placed in bridge deck and dewatering is solved	
5	Bearing areas	1	no visual defects	
6	Main girders/Beams	1	24 beams are construct and installed no visual defects	
7	Cross girders	1	6 2 12 end cross girders and 12 middle cross girders are construct no visual defects	
7	Expansion joints		not installed	dilatation joints to be set immediately
8	Drainage system		not constructed	
9	Level of Completion		1. SUBSTRUCTURE 100 2. SUPERSTRUCTURE 90	
10	Designing		Main Project

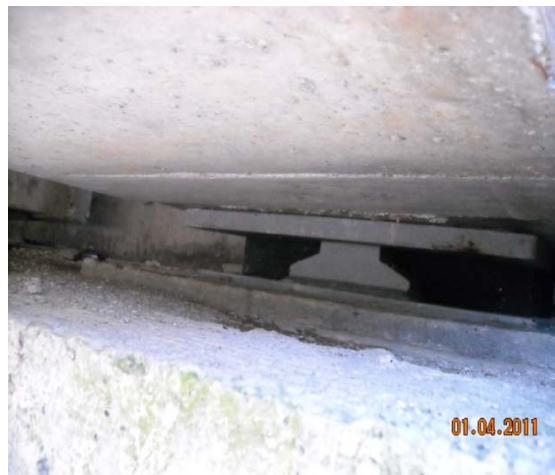
Bridge	Bridge No.	length	width	chainage	Bridge type	Date of Inspection
Section	PEAONI A 56+438 - 66+050	20	4X25 100m	6.5m	km 62+505.00	RC viaduct
						01.04.2011

No	ELEMENT	CONDITION CLASS	DEFECTS DESCRIPTION	MEASURES
1	Abutments	1	2 oval abutment with parallel wings are constructed [no visual defects]	
2	Piers	1	3 piers constructed [no visual defects]	
3	Deck	1	constructed [no visual defects]	
4	Culvert		pipes are placed in bridge deck and dewatering is solved	
5	Bearing areas	1	[no visual defects]	
6	Main girders/Beams	1	16 beams are construct and installed [no visual defects]	
7	Cross girders	1	4 28 end cross girders and 8 middle cross girders are construct [no visual defects]	
7	Expansion joints		not installed	to install immediately
8	Drainage system		not constructed	
9	Level of Completion []		1. SUBSTRUCTURE 100 2. SUPERSTRUCTURE 90	
10	Designing		Main Project

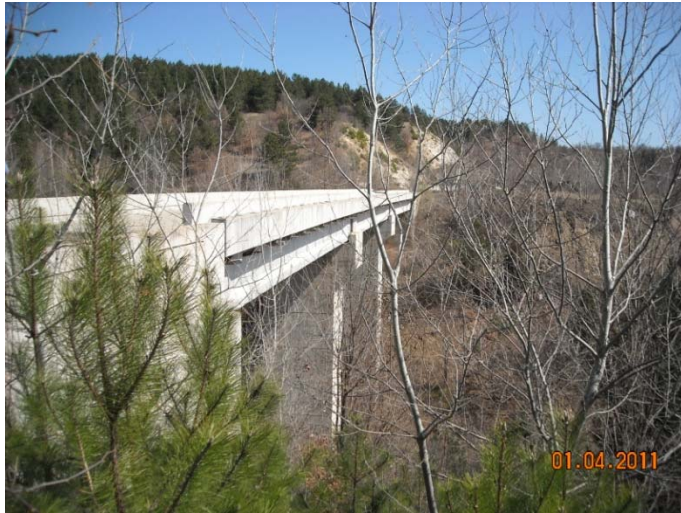
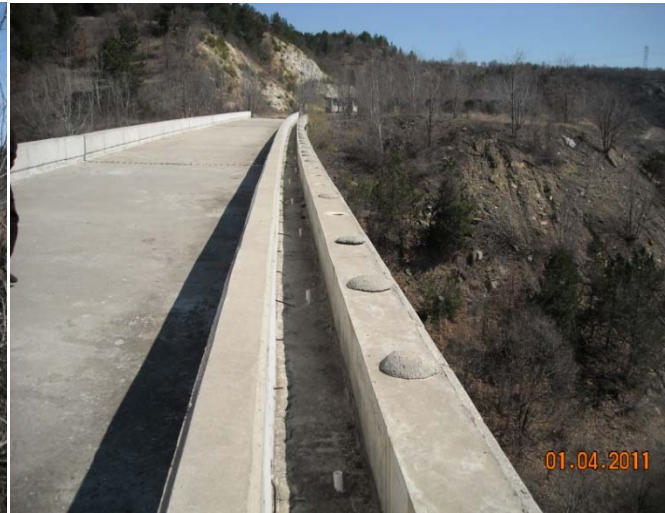
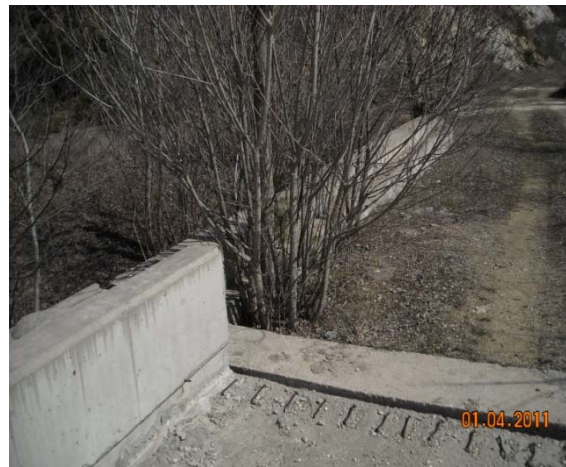
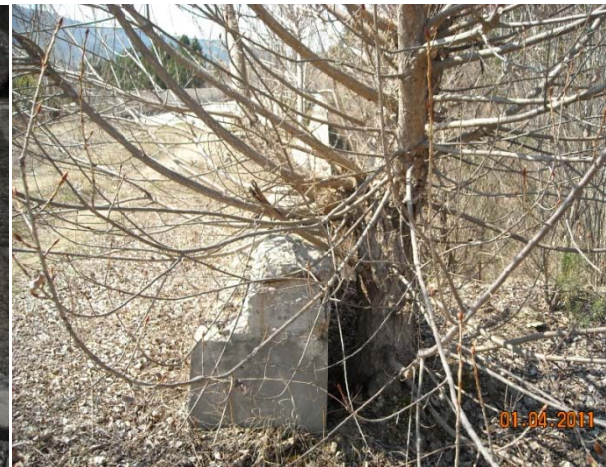
Bridge	Bridge No.	length	width	chainage	Bridge type	Date of Inspection
Section	PEPAONI A 56+438 - 66+050	23	135	6.5m	km 63+392.00	RC viaduct

No	ELEMENT	CONDITION CLASS	DEFECTS DESCRIPTION	MEASURES
1	Abutments	1	2 oval abutment with parallel wings are constructed [no visual defects]	
2	Piers		not constructed	
3	Deck		not constructed	
4	Culvert		not constructed	
5	Bearing areas		they are installed, but it's missing the upper part of free bearings	
6	Main girders/Beams		2 prestressed beams are installed and they have big deflection	to be loaded
7	Cross girders		2 end cross girders are construct	
7	Expansion joints		not installed	
8	Drainage system		not constructed	
9	Level of Completion [%]		1. SUBSTRUCTURE 100% 2. SUPERSTRUCTURE 35%	
10	Designing		Main Project

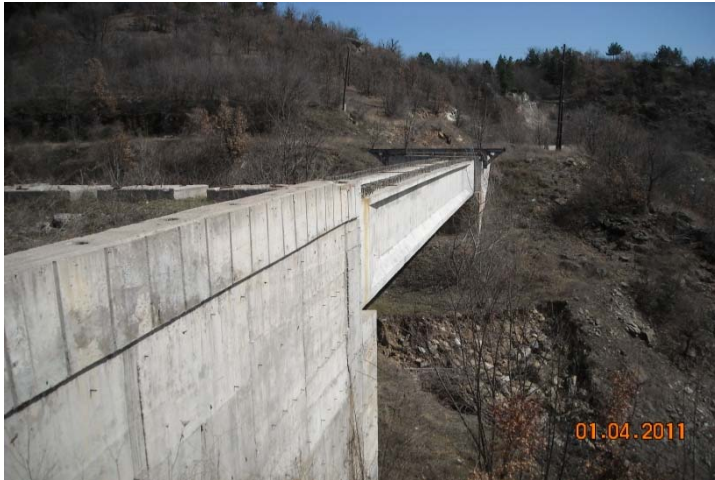
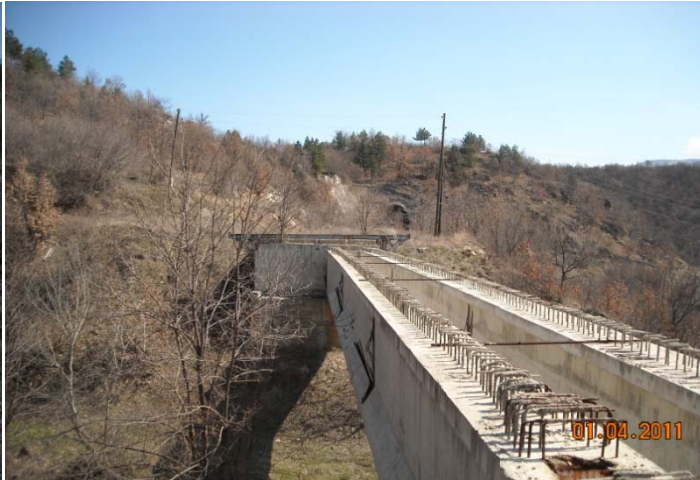
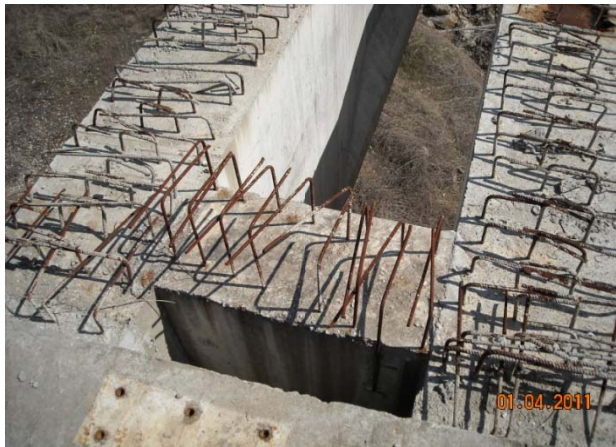
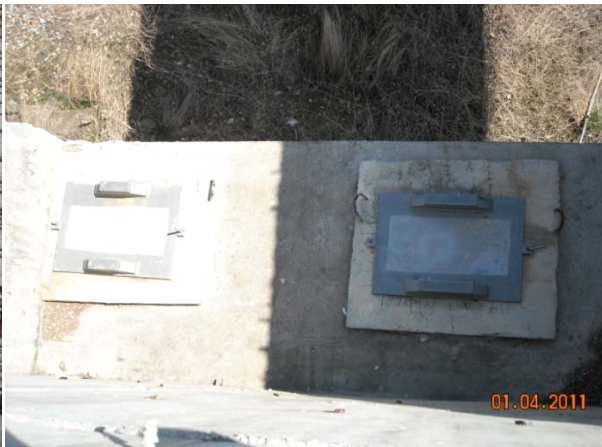
Bridge	Bridge No.	length	width	chainage	Bridge type	Date of Inspection	
Section	PEAONI A 56+438 - 66+050	24	5 25 125	6.5m	km 63+710.00	RC Bridge	01.04.2011

No	ELEMENT	CONDITION CLASS	DEFECTS DESCRIPTION	MEASURES
1	Abutments	2	2 oval abutment with parallel wings are constructed [no visual defects]	
2	Piers	1	4 piers are constructed [no visual defects]	
3	Deck		not constructed	
4	Culvert		not constructed	
5	Bearing areas		not installed	
6	Main girders/Beams		1. 20 beams are constructed, they are not prestressed and they are not installed 2. 1 beams is fallen and it has cracks	to inspect and repair immediately
7	Cross girders		not constructed	
7	Expansion joints		not installed	
8	Drainage system		not constructed	
9	Level of Completion [%]		1. SUBSTRUCTURE 100% 2. SUPERSTRUCTURE 65%	
10	Designing		Main Project

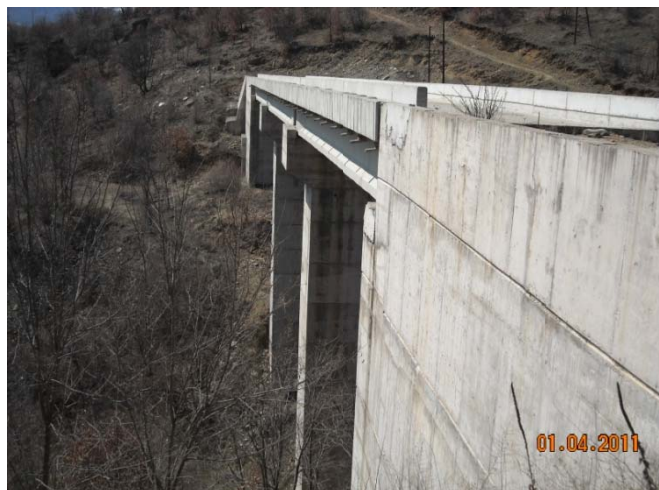
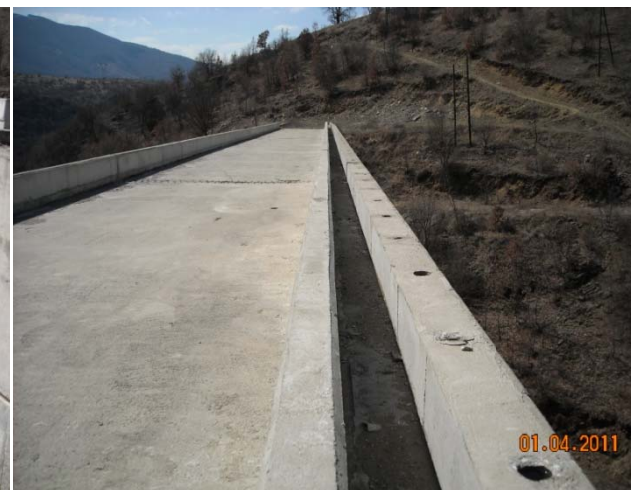
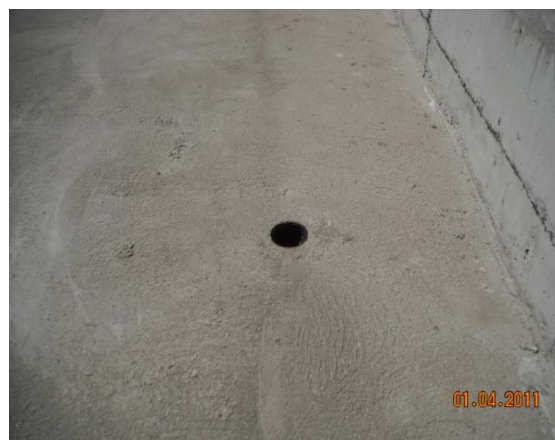
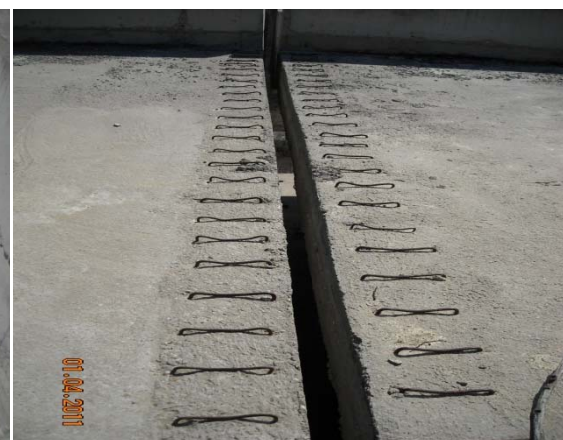
Bridge		Bridge No.	length	width	chainage	Bridge type	Date of Inspection
Section	PEPAONI A 56+438 - 66+050	26	3x25 x75m	6.5m	km 65+198.00	RC viaduct	01.04.2011

No	ELEMENT	CONDITION CLASS	DEFECTS DESCRIPTION	MEASURES
1	Abutments	1	2 oval abutment with parallel wings are constructed [no visual defects]	
2	Piers	1	2 piers are constructed [no visual defects]	
3	Deck	1	no visual defects	
4	Culvert	1	pipes for dewatering are installed in the deck	
5	Bearing areas	1	no visual defects	
6	Main girders/Beams	1	12 beams are constructed and installed [no visual defects]	
7	Cross girders	1	6 end cross girders and 6 middle cross girders are constructed	
7	Expansion joints		not installed	to install immediately
8	Drainage system		not constructed	
9	Level of Completion [%]		1. SUBSTRUCTURE 100% 2. SUPERSTRUCTURE 90%	
10	Designing		Main Project

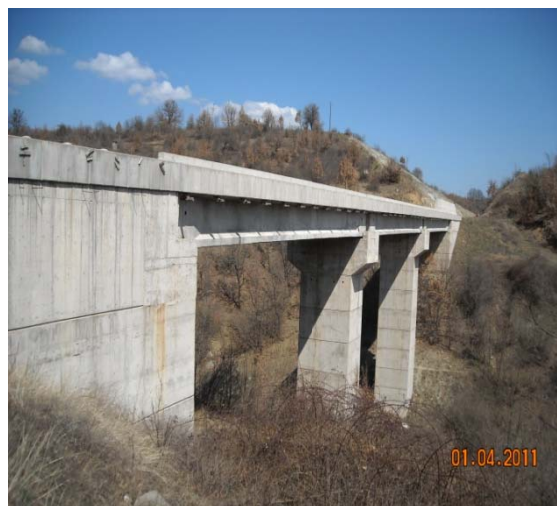
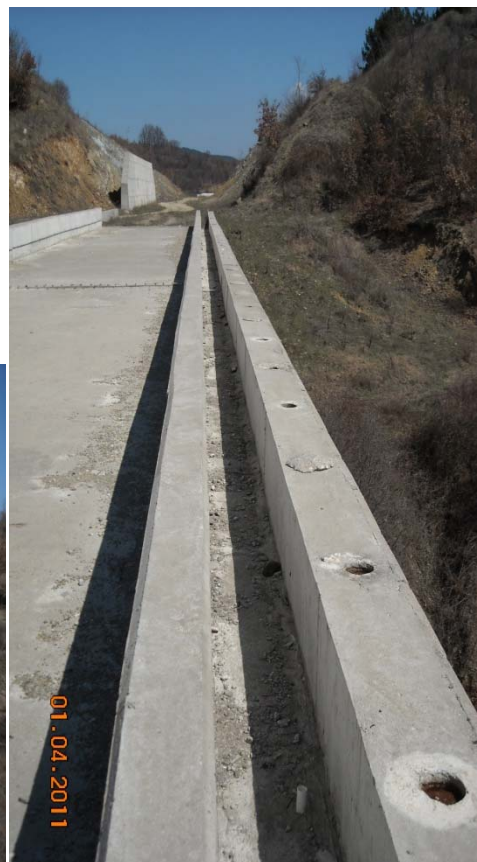
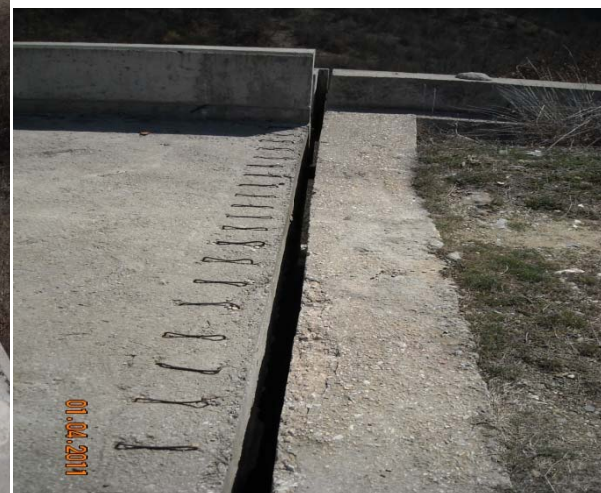
Bridge	Bridge No.	length	width	chainage	Bridge type	Date of Inspection	
Section	PEAONI A 56+438 - 66+050	27	625 150m	6.5m	km 65+537.00	RC viaduct	01.04.2011

No	ELEMENT	CONDITION CLASS	DEFECTS DESCRIPTION	MEASURES
1	Abutments	1	2 oval abutment with parallel wings are constructed [no visual defects]	
2	Piers	1	5 piers are constructed [no visual defects]	
3	Deck	1	no visual defects	
4	Culvert	1	pipes for dewatering are installed in the deck	
5	Bearing areas	2	in the [one of bearings it has fallen stones	to clean
6	Main girders/Beams	1	24 beams are constructed and installed [no visual defects]	
7	Cross girders	1	12 end cross girders and 12 middle cross girders are constructed	
7	Expansion joints	2	in first dilatation it has fallen stones	to clean and install the dilatations
8	Drainage system		not constructed	
9	Level of Completion []		1. SUBSTRUCTURE 100% 2. SUPERSTRUCTURE 90%	
10	Designing		Main Project

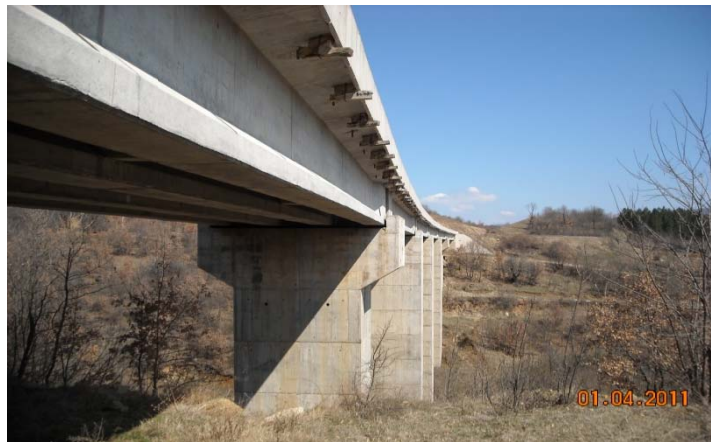
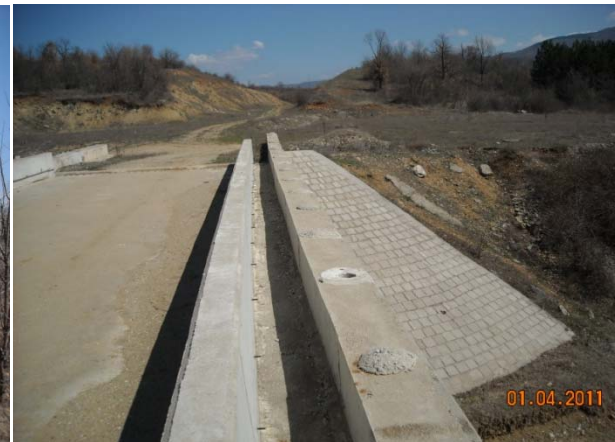
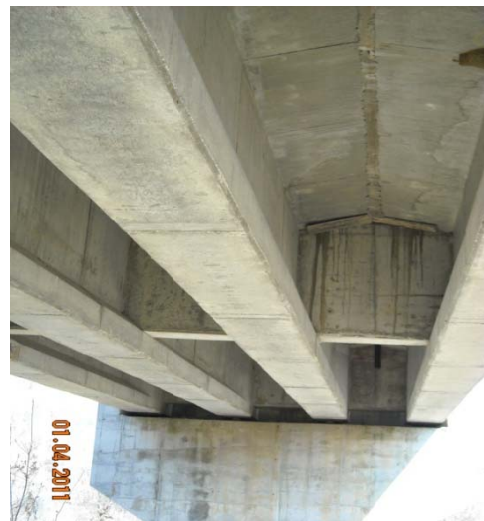
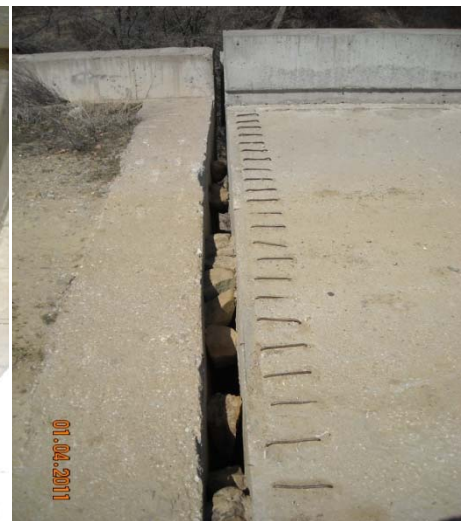
Bridge		Bridge No.	length	width	chainage	Bridge type	Date of Inspection
Section	PEPAONI A 56+438 - 66+050	28	425 100m	6.5m	km 65+954.00	RC viaduct	01.04.2011

No	ELEMENT	CONDITION CLASS	DEFECTS DESCRIPTION	MEASURES
1	Abutments	2	2 oval abutment with parallel wings are constructed 1st - segregated from the wing parapet	
2	Piers	1	4 piers are constructed no visual defects	
3	Deck	1	no visual defects	
4	Culvert	1	pipes for dewatering are installed in the deck	
5	Bearing areas		no visual defects	
6	Main girders/Beams		14 beams are constructed and installed no visual defects	
7	Cross girders		8 end cross girders and 8 middle cross girders are constructed	
7	Expansion joints		not constructed	to be set immediately
8	Drainage system		not constructed	
9	Level of Completion		1. SUBSTRUCTURE 100% 2. SUPERSTRUCTURE 90%	
10	Designing		Main Project

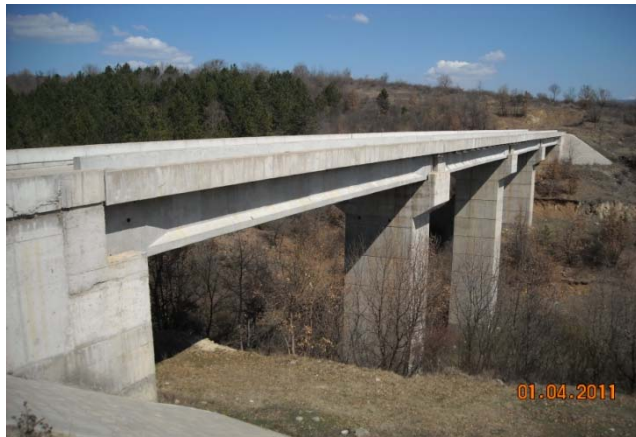
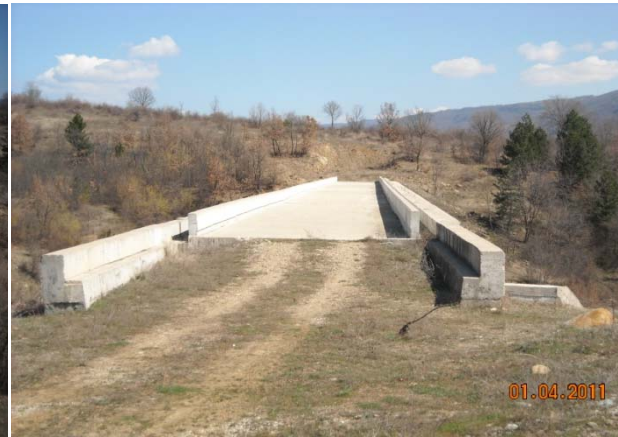
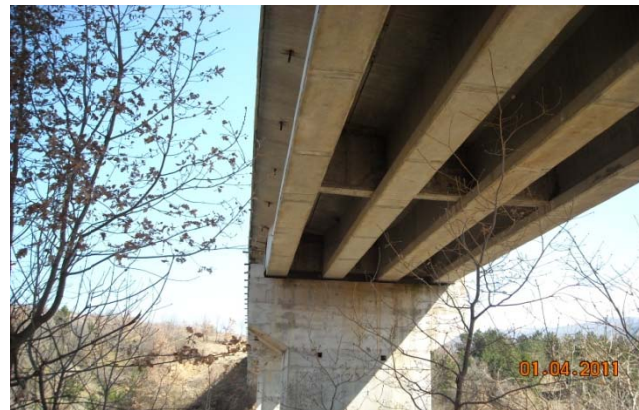
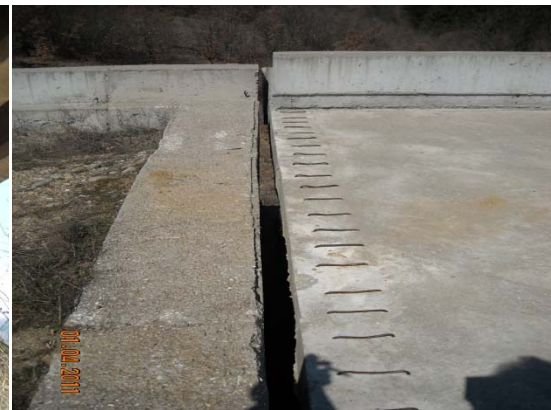
Bridge		Bridge No.	length	width	chainage	Bridge type	Date of Inspection
Section	PEAONI 56+438 - 66+050	underpass	8m	6.5m	km 57+822.00	RC viaduct	01.04.2011

No	ELEMENT	CONDITION CLASS	DEFECTS DESCRIPTION	MEASURES
1	Abutments	2	no visual defects	
2	Piers	1		
3	Deck	1	no visual defects	
4	Culvert			
5	Bearing areas	1		
6	Main girders/Beams	1		
7	Cross girders	1		
7	Expansion joints			
8	Drainage system			
9	Level of Completion		1. SUBSTRUCTURE 95% 2. SUPERSTRUCTURE 95%	
10	Designing		Main Project
