This supplementary Site Inspection Record for existing structures presents the Consultant's findings in respect of all the bridges and tunnels on the project railway line from Kumanovo to Bulgarian border. This report is additional to the requirements of the Terms of Reference and Task 4 Development of Preferred Alternative for the Feasibility Study. This report summarises the research into the condition of the bridges and tunnels and is used for consequential costs for their construction or finalisation.

BRIDGE INSPECTION RECORD (NO ACCESS TO THE OBJECT)							
Bridge		Bridge No.	length	width	chainage	Bridge type	Date of Inspection
Section	MAVROVO 37+624 - 44+390	7	2X25 (50m)	6.5m	km 40+014.00	RC Viaduct	29.03.2011

BRIDGE INSPECTION RECORD							
Bridge		Bridge No.	length	width	chainage	Bridge type	Date of Inspection
Section	GRANIT 44+390 - 55+500	12	13X36 (468m)	6.5m	km 46+068.00	RC Viaduct	29.03.2011

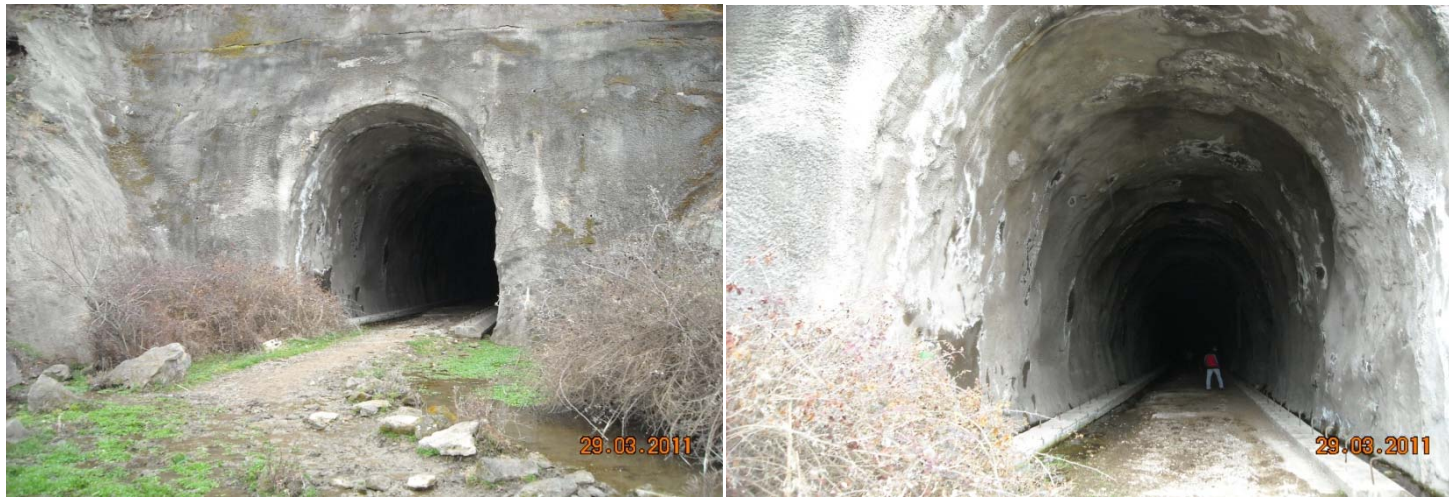
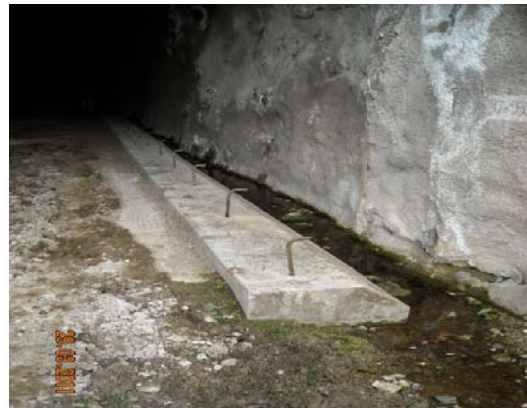
Tunnel	Tunnel No.	Length	Width	Chainage	Rock type	Date of inspection
Section	Mavrovo 37+624 - 44+390	2	169m	4.7m	km40+758 Type III - 83m Type I - 46m Type II - 37m	24.03.2011

No	ELEMENT	CONDITION CLASS	DEFECTS DESCRIPTION	MEASURES
1	Cave - in	2	Due to undulating surface on site, works on bearing plate are stopped Tunnel is fully drilled /drilled/ with primary tunnel lining done	Reinforced bearing plate to be done
2	Portal /faults in concrete/	2	Construction works at the exit portal approaching cutting on the left side are stopped	To make sanction with concrete inject and hanger with anchors
3	Water leakage		Is not done	
4	Erosion		There is no visual erosion	
5	Slope Protection		Part from right side at the exit approach cutting is unstable	Sanction to be done
6	Drainage system		Is not done	
7	Level of Completion [] []			
8	Designing		There is a project	
			1 Entrance/exit approach cutting is made with concrete inject and anchors	
			2 Tunnel is drilled /drilled/ with done primary tunnel lining	
			3 Bearing plate /tie-plate/ is 100% done

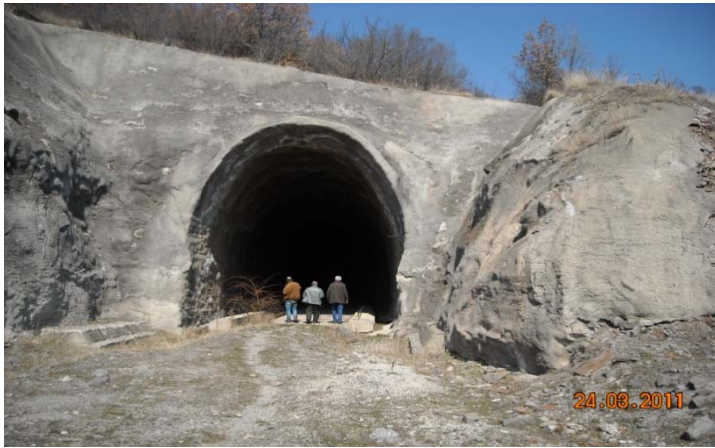
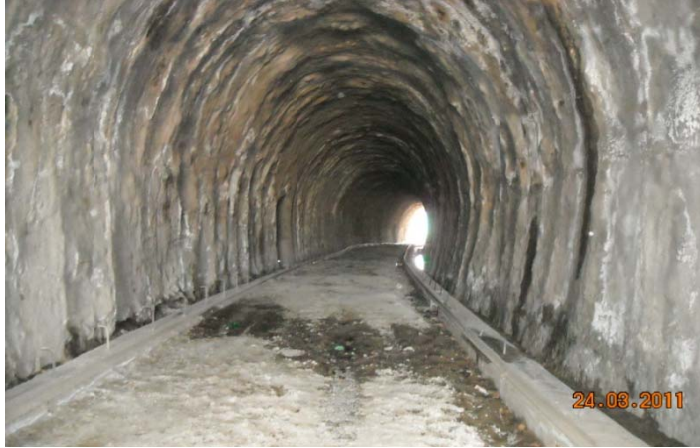
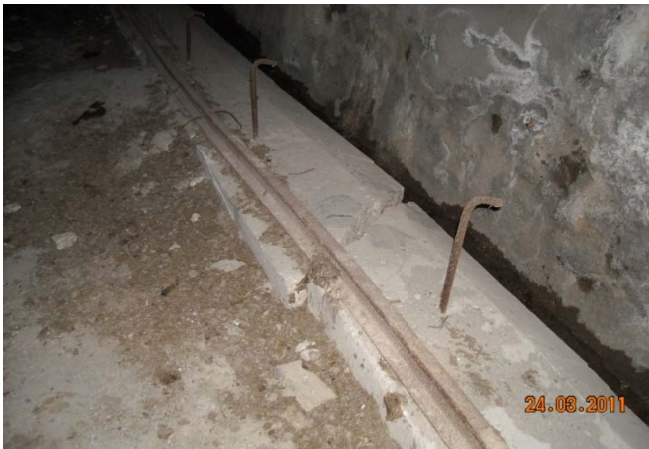
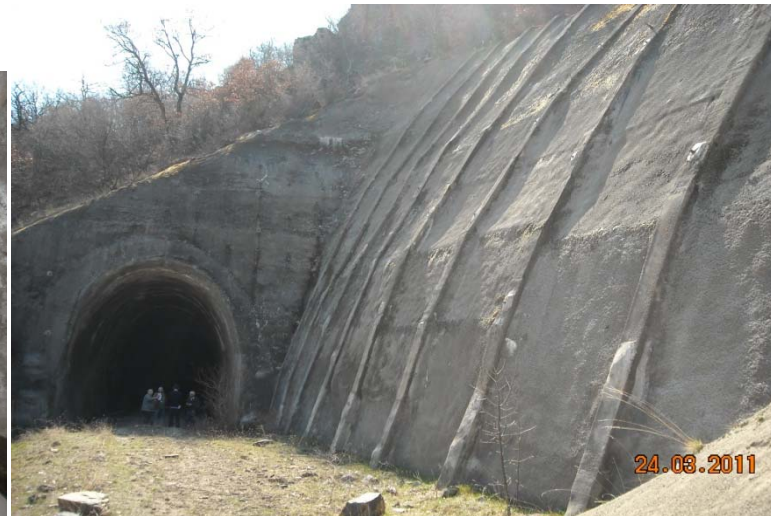
Tunnel		Tunnel No.	Length	Width	Chainage	Rock type	Date of inspection
Section	Mavrovo 37+624 - 44+390	3	364m	4.7m	km41+607	Type I - 40m Type II - 151m Type III - 7m Type IV - 150m Type V - 16m	29.03.2011 Tuesday

No	ELEMENT	CONDITION CLASS	DEFECTS DESCRIPTION	MEASURES
1	Cave - in	1	No visual defects Tunnel is drilled with primary and secondary tunnel lining 100%	
2	Portal faults in concrete	1	Entrance/exit portal is concreted	
3	Water leakage	1	Dewatering is done 70%	To be completed
4	Erosion		No erosion	
5	Slope Protection		Slopes are stable	
6	Drainage system	1	Drainage system is done	
7	Level of Completion (%)		Completion percentage of the tunnel is 95%	
8	Designing		There is a project	
9

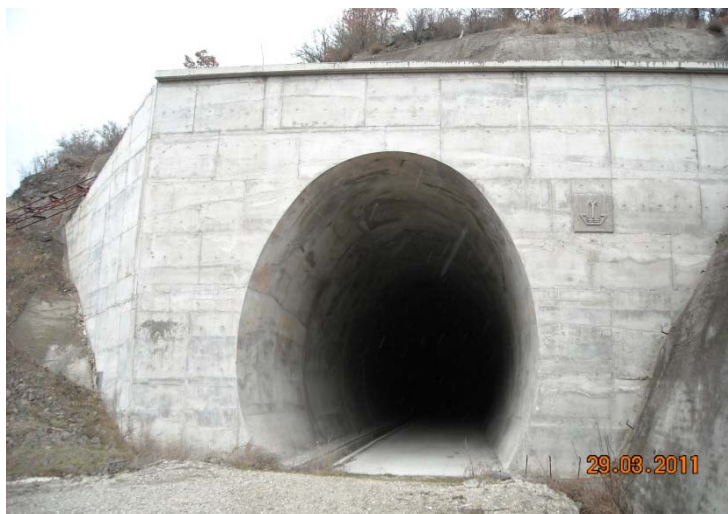
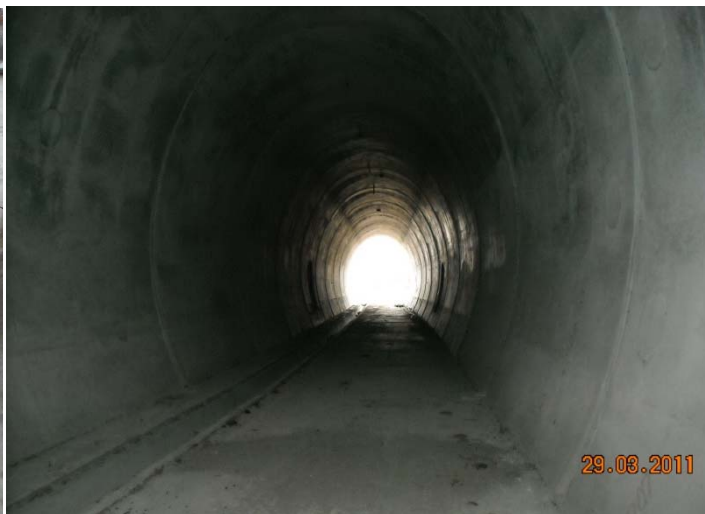
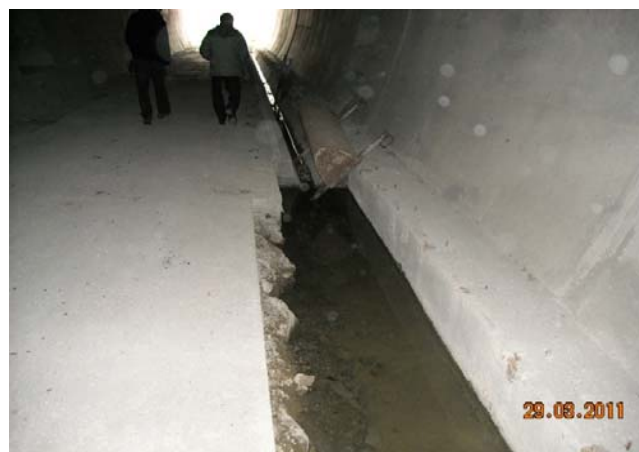
Tunnel		Tunnel No.	Length	Width	Chainage	Rock type	Date of inspection
Section	Mavrovo 37+624 - 44+390	4	341	4,7	km42+250	Type II - 60m Type III - 265.5m Type I - 14m	29.03.2011 Tuesday

No	ELEMENT	CONDITION CLASS	DEFECTS DESCRIPTION	MEASURES
1	Cave - in	1	No visual defects Tunnel is completely drilled and primary tunnel lining is done 100% Epoxy tile and isolation membrane is installed 60% Secondary tunnel lining is 50% done 170m	
2	Portal faults in concrete	1	Entrance/exit portals approach cutting has no faults/defects	
3	Water leakage		Is not done	
4	Erosion		No	
5	Slope Protection	1	Slopes are stable	
6	Drainage system	1	Drainage is done 50% at the part of secondary tunnel lining	
7	Level of Completion			
8	Designing		There is a project	
			1 Entrance/exit approach cutting is done with concrete inject and anchors	
			2 Tunnel is drilled and there is primary and secondary tunnel lining, 50% completed	
			3 Bearing plate tie-plate is 100% done

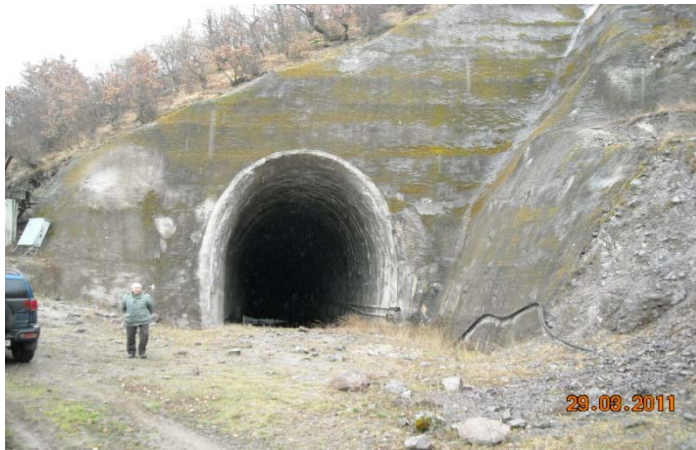
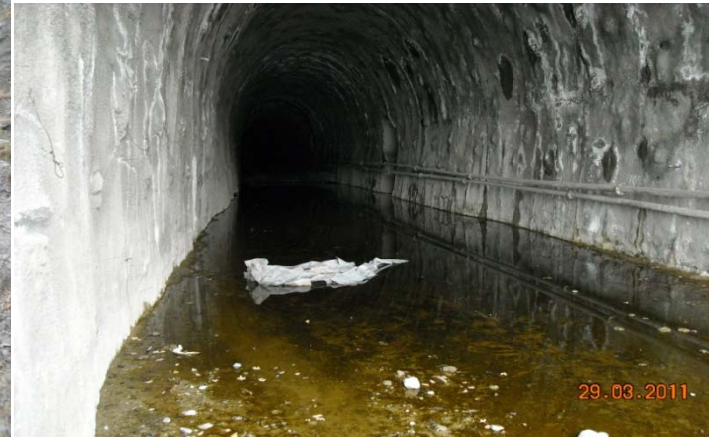
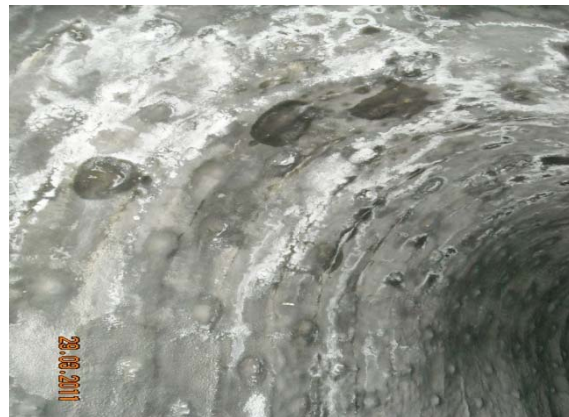
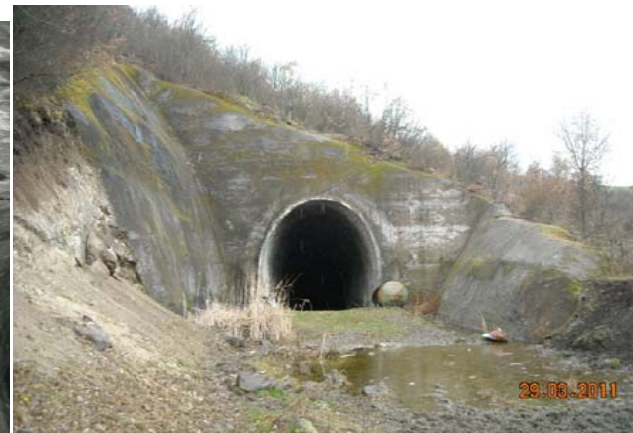
Tunnel	Tunnel No.	Length	Width	Chainage	Rock type	Date of inspection
Section	Mavrovo 37+624 - 44+390	5	256m	4.7m	km42+779 Type III - 55.5 Type I - 175m Type II - 20.5m	29.03.2011 Tuesday

No	ELEMENT	CONDITION CLASS	DEFECTS DESCRIPTION	MEASURES
1	Cave - in	1	No visual defects	
2	Portal faults in concrete	1	Entrance/exit approach cutting is done with concrete inject with anchors	
3	Water leakage		There is water in the tunnel	Tunnel to be dewatered
4	Erosion		No	
5	Slope Protection		Slopes are stable	
6	Drainage system		Is not done	
7	Level of Completion			
8	Designing		There is a project	
9			1 Entrance/exit approach cutting is done with concrete inject and anchors	
10			2 Tunnel is driven and primary tunnel lining is done	
11			3 Bearing plate is not done.

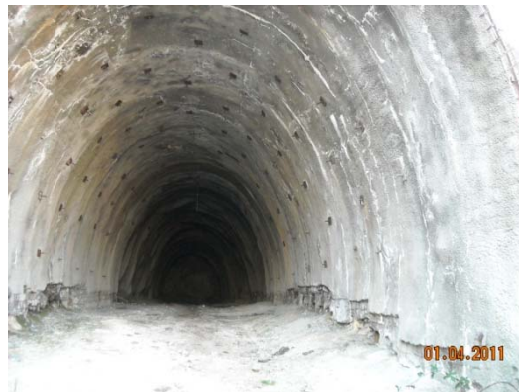
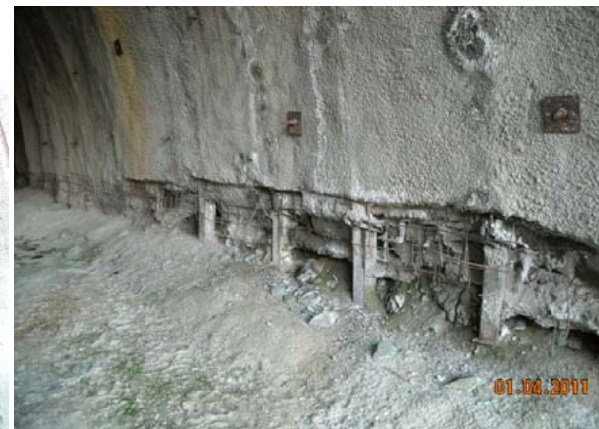
Tunnel	Tunnel No.	Length	Width	Chainage	Rock type	Date of inspection
Section	km44+390 - km55+500	6	188m	4,7	km49+802	01.04.2011 Friday

No	ELEMENT	CONDITION CLASS	DEFECTS DESCRIPTION	MEASURES
1	Cave - in	2	No visual defects (tunnel is drilled and there is primary tunnel lining 70-75m)	
2	Portal (faults in concrete)	3	Left portal has cracks	Sanction to be done
3	Water leakage		Is not done	
4	Erosion		There is small erosion in nipper on primary tunnel lining	Sanction to be done
5	Slope Protection	3	Right side from left approach cutting has unstable slope	Concrete wall to be constructed
6	Drainage system		Is not done	
7	Level of Completion (%)			
8	Designing		There is a project	
			1. Left approach cutting with concrete inject and anchors	
			2. Tunnel is drilled 40m and has primary tunnel lining	
			3. Bearing plate has not been started

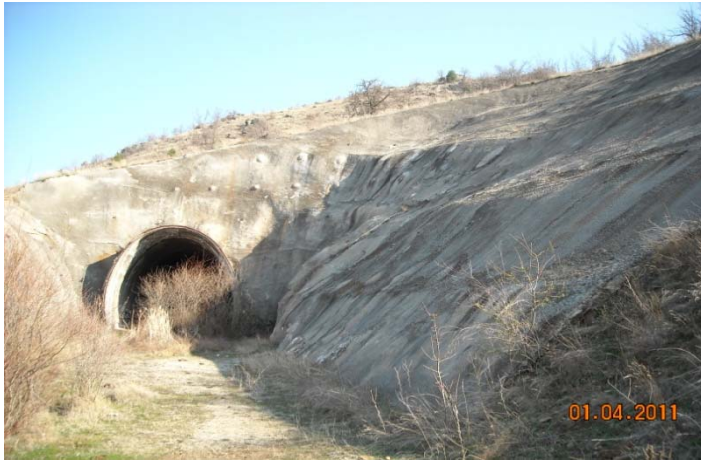
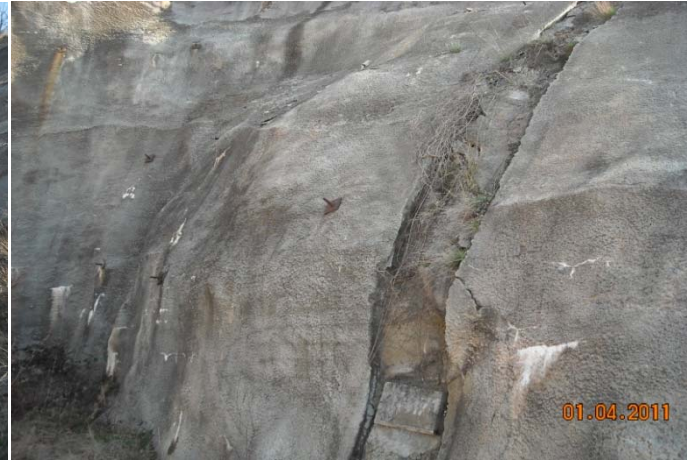
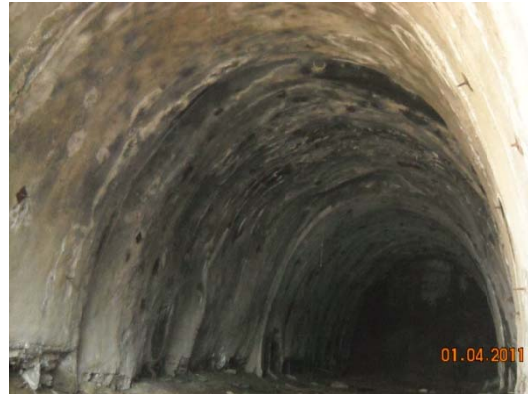
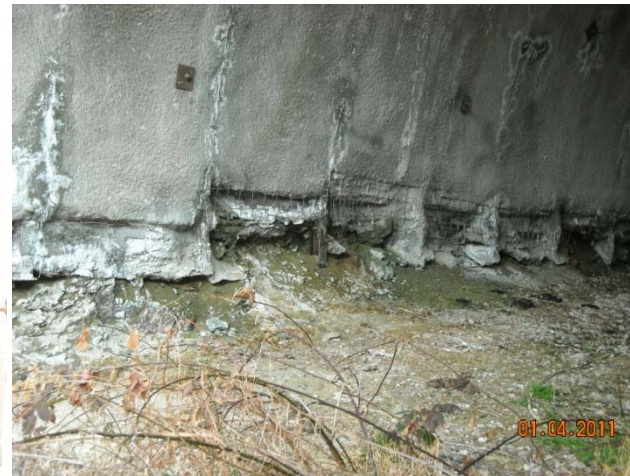
Tunnel	Tunnel No.	Length	Width	Chainage	Rock type	Date of inspection
Section	Granit km44+390 - 55+500	6a	592m	4,7	km50+171	01.04.2011 Friday

No	ELEMENT	CONDITION CLASS	DEFECTS DESCRIPTION	MEASURES
1	Cave - in	2	Primary tunnel lining is loosen, tunnel has been drilled 40-45m and primary tunnel lining is done	Sanction to be done
2	Portal - faults in concrete	2	Entrance portal approach cutting is done and concrete inject with anchors	
3	Water leakage		There is water at the entrance of the tunnel	Dewatering to be solved
4	Erosion		In nipper from primary tunnel lining	
5	Slope Protection		No visual defects	Sanction to be done
6	Drainage system		Is not done	
7	Level of Completion			
8	Designing		There is a project	
9			1 - Entrance approach cutting is done, concrete inject and anchors	
10			2 - Tunnel is driven 8 - and primary tunnel lining is done	
11			3 - Bearing plate has not been started

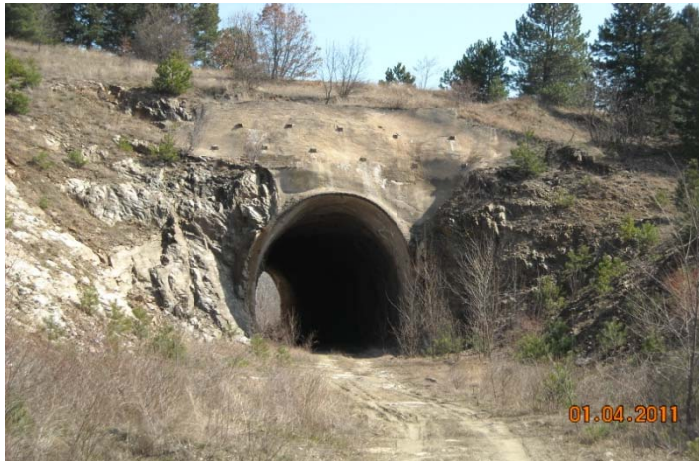
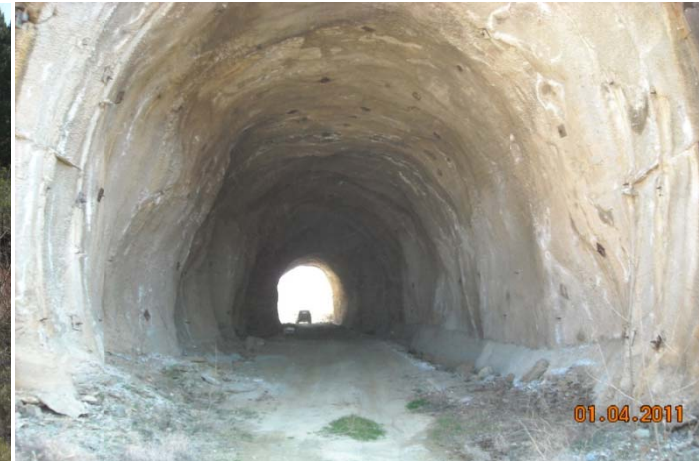
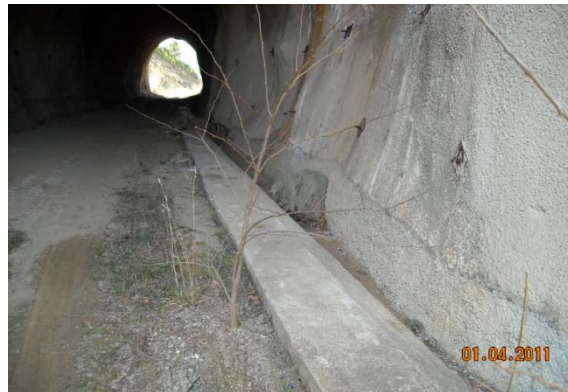
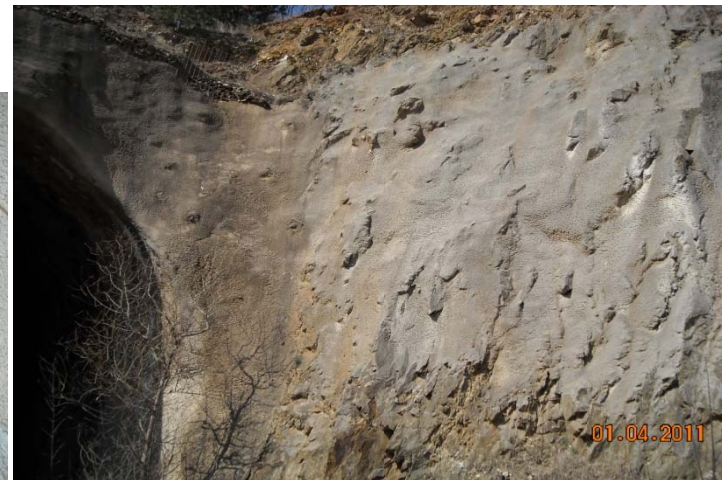
Tunnel		Tunnel No.	Length	Width	Chainage	Rock type	Date of inspection
Section	Pelagonija km56+438-66+050	8	1000	4.7m	km62+677		01.04.2011 Friday

No	ELEMENT	CONDITION CLASS	DEFECTS DESCRIPTION	MEASURES
1	Cave - in	2	Tunnel is widely drilled and primary tunnel lining has been done	
2	Portal faults in concrete	3	Entrance approach cutting is not completed and exit approach cutting from left side has bad concrete inject	Complete concrete inject to be done
3	Water leakage		There is no water in the tunnel	
4	Erosion		There is collapsing on one part in down area	Sanction on concrete to be done
5	Slope Protection		Slopes are stable	
6	Drainage system		Is not done	
7	Level of Completion			
8	Designing		There is project	
			1 Entrance/exit approach cutting is partly done	
			2 Tunnel is drilled and primary tunnel lining is done	
			3 Bearing plate is 50% done

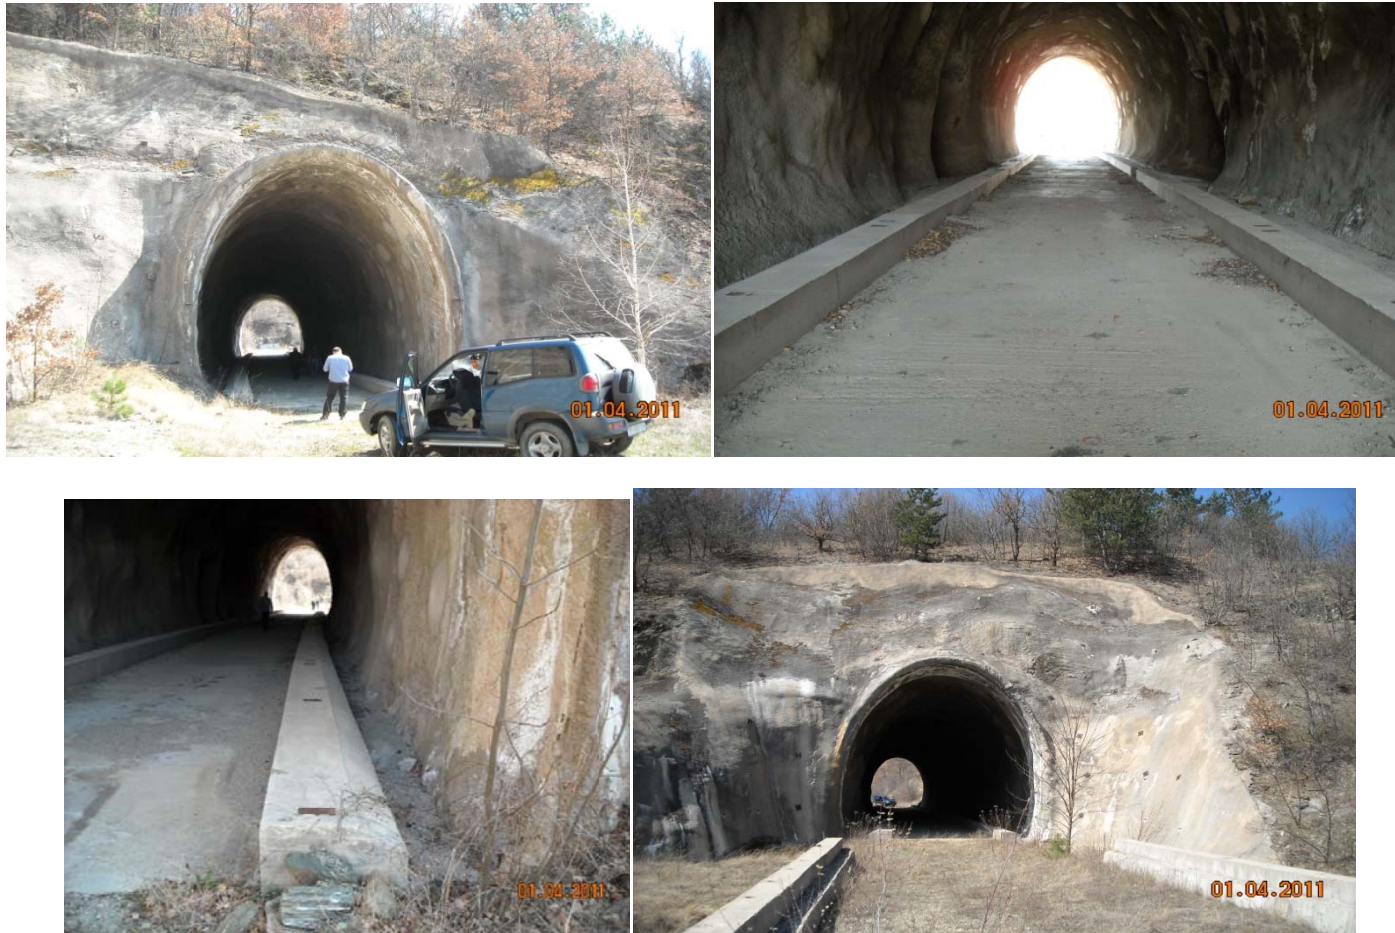
Tunnel	Tunnel No.	Length	Width	Chainage	Rock type	Date of inspection
Section	Pelagonija km56+438-66+050	9	73m	4.7m	km63+552	01.04.2011 Friday

No	ELEMENT	CONDITION CLASS	DEFECTS DESCRIPTION	MEASURES
1	Cave - in	1	No visual defects Tunnel is drilled /drilled/ Primary tunnel lining is done	
2	Portal /faults in concrete/	2	Entrance and exit approach cutting has cracks at concrete injection	Sanction to be done
3	Water leakage		Is not done	
4	Erosion		No visual erosion	
5	Slope Protection		Slopes are stable	
6	Drainage system		Is not done	
7	Level of Completion			
8	Designing		There is a project	
			1 Entrance/exit approach cutting is done with concrete injection and anchors	
			2 Tunnel drilled /drilled/ with done primary tunnel lining	
			3 Bearing plate /tie-plate/ is 50% done

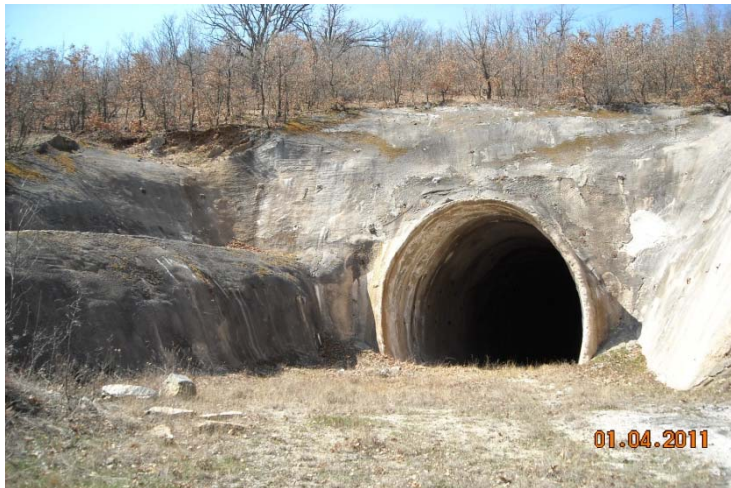
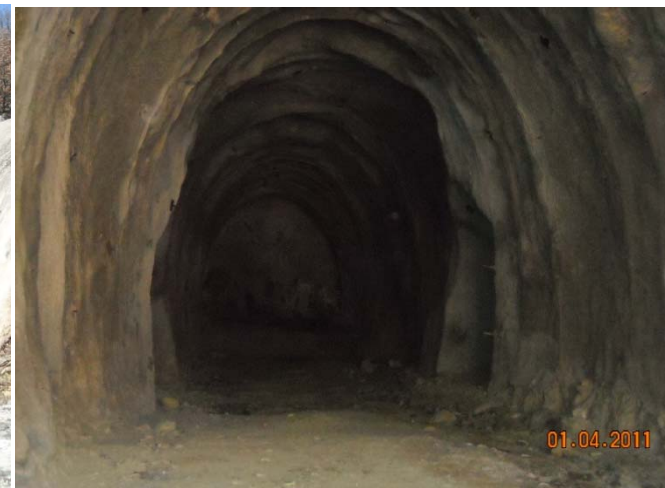
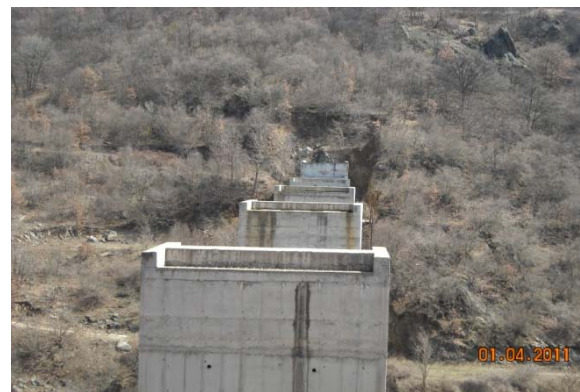
Tunnel		Tunnel No.	Length	Width	Chainage	Rock type	Date of inspection
Section	Pelagonija km56+438-66+050	10	248m	4.7m	km63+807		01.04.2011 Friday

No	ELEMENT	CONDITION CLASS	DEFECTS DESCRIPTION	MEASURES
1	Cave - in	2	Tunnel from exit side is driven with 90-95m Tunnel from entrance side is not started. From exit side portal is injected and tunnel is driven 90-95m and primary tunnel lining has been done	
2	Portal faults in concrete	2	Exit approach cutting is done with concrete inject and anchors inject has cracks	Sanction of inject to be done
3	Water leakage		Is not done	
4	Erosion		No visual erosion	
5	Slope Protection		Slopes are stable	
6	Drainage system		Is not done	
7	Level of Completion			
8	Designing		There is project	
			1 Exit approach cutting has concrete inject with anchors	
			2 From exit side tunnel is driven 90-95m and primary tunnel lining is done 35	
			3 Bearing plate tie-plate is not done

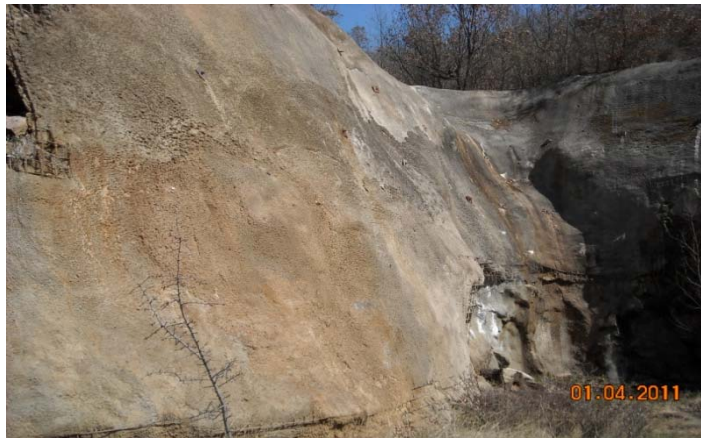
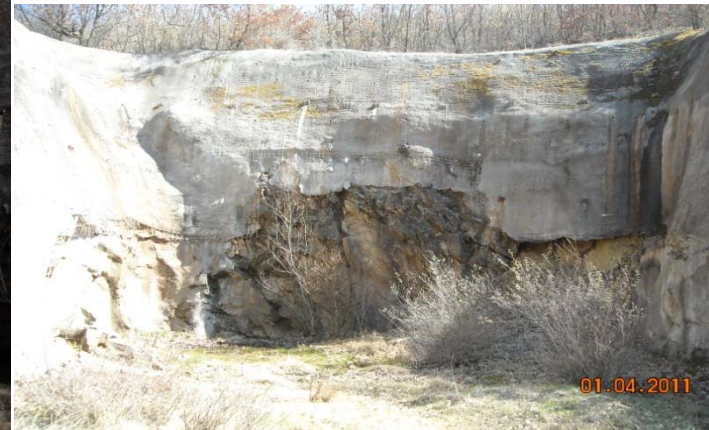
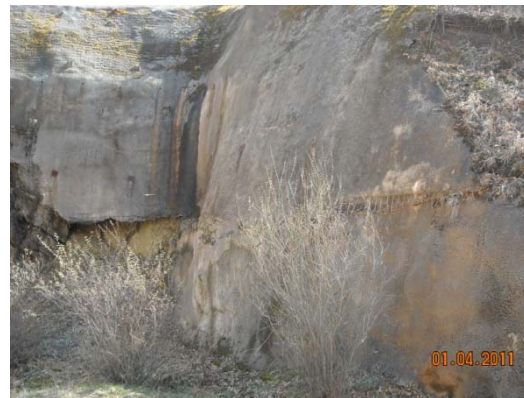
Tunnel		Tunnel No.	Length	Width	Chainage	Rock type	Date of inspection
Section	Pelagonija km56+438-66+050	11	172m	4.7m	km64+154		01.04.2011 Friday

No	ELEMENT	CONDITION CLASS	DEFECTS DESCRIPTION	MEASURES
1	Cave - in		No works	
2	Portal faults in concrete		Approach cutting is excavated and protected with concrete inject and anchors	
3	Water leakage		No works for drilling driving the tunnel	
4	Erosion			
5	Slope Protection			
6	Drainage system			
7	Level of Completion			
8	Designing		There is a project	
9				
10

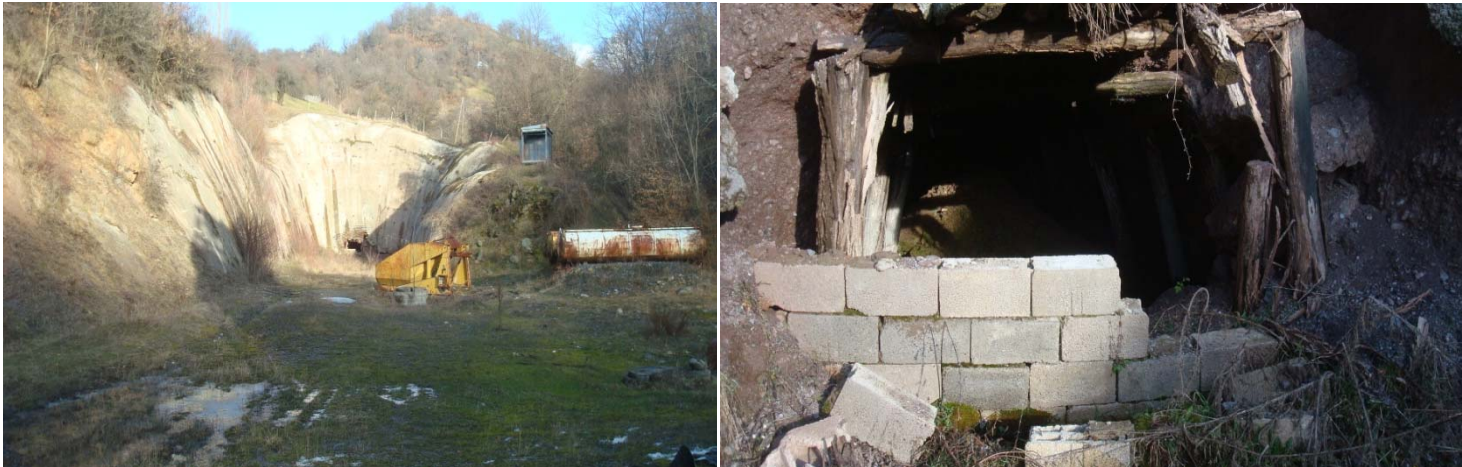
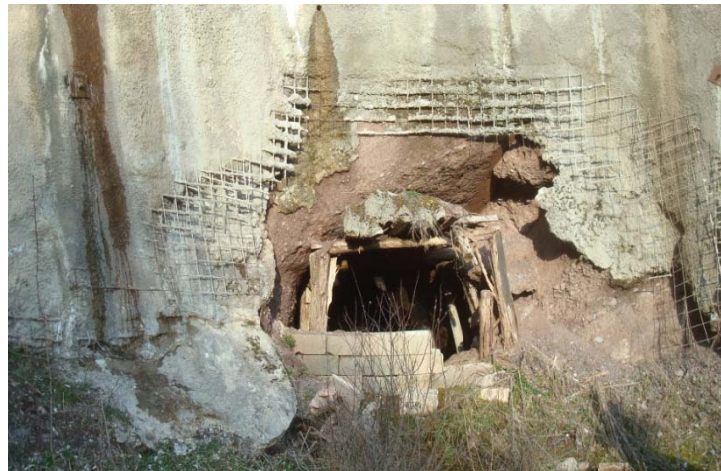
No	ELEMENT	CONDITION CLASS	DEFECTS DESCRIPTION	MEASURES
1	Cave - in		Concrete injection done at the entrance approach cutting	
2	Portal faults in concrete		Tunnel needs to be driven with new profile	
3	Water leakage			
4	Erosion			
5	Slope Protection			
6	Drainage system			
7	Level of Completion			
8	Designing		No project	
9				
10
